# REHABILITATION REPORT

## 1 February 2019 to 31 January 2020

Mt Boppy Gold Mine  
Canbelego NSW

Document ID: 2020 Rehabilitation Report

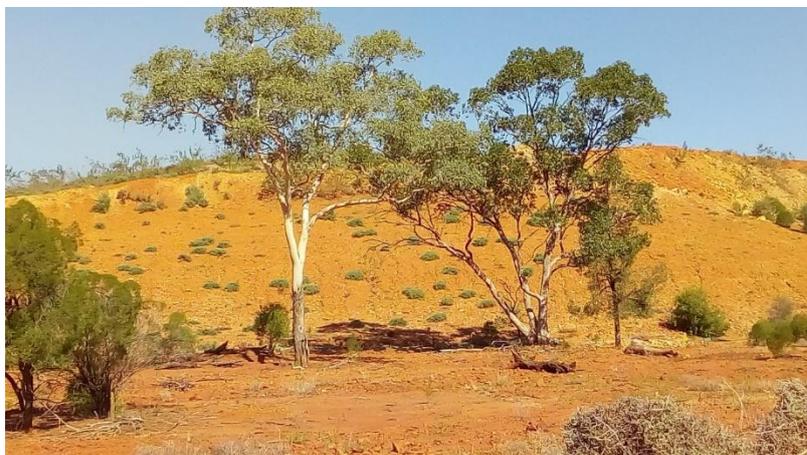
**Figures 4 and 5** show current site conditions. **Figure 4** was the site of significant works on the north western wall of the TSF, which had been re-profiled, topsoil applied and seeded with native seed in 2016.

Figure 4: North western wall of TSF showing groundcover species continuing to grow despite dry weather.  
Photo taken February 2019.

The reporting period over 2019 was again a drier than average year with limited storm activity. Coverage which was previously established has managed to stay alive however new growth has been limited.

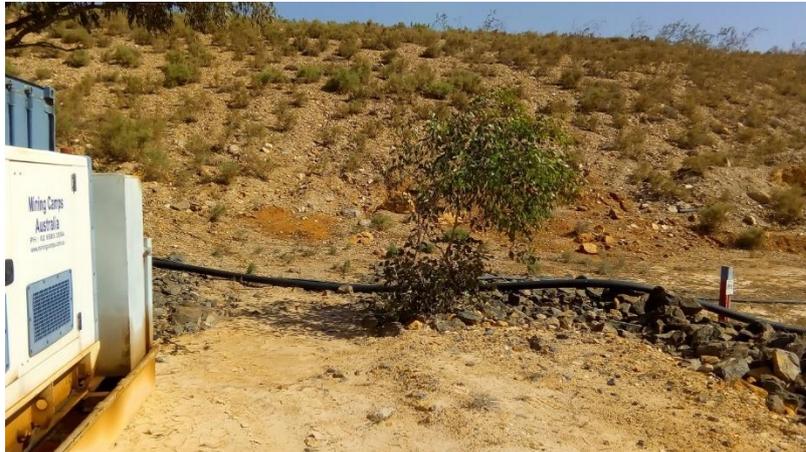
**Figure 5** shows a section of the eastern embankment of the WRE which has achieved groundcover levels consistent with the natural surrounds. Shrub species include grey copper burr and *Maeireana brevifolia* amongst scattered annual grasses, which is providing good soil stabilisation and prevention of erosion.

Figure 5: **Northern side of TSF embankment with established groundcover, representing the target groundcover levels.** Photo taken February 2019.

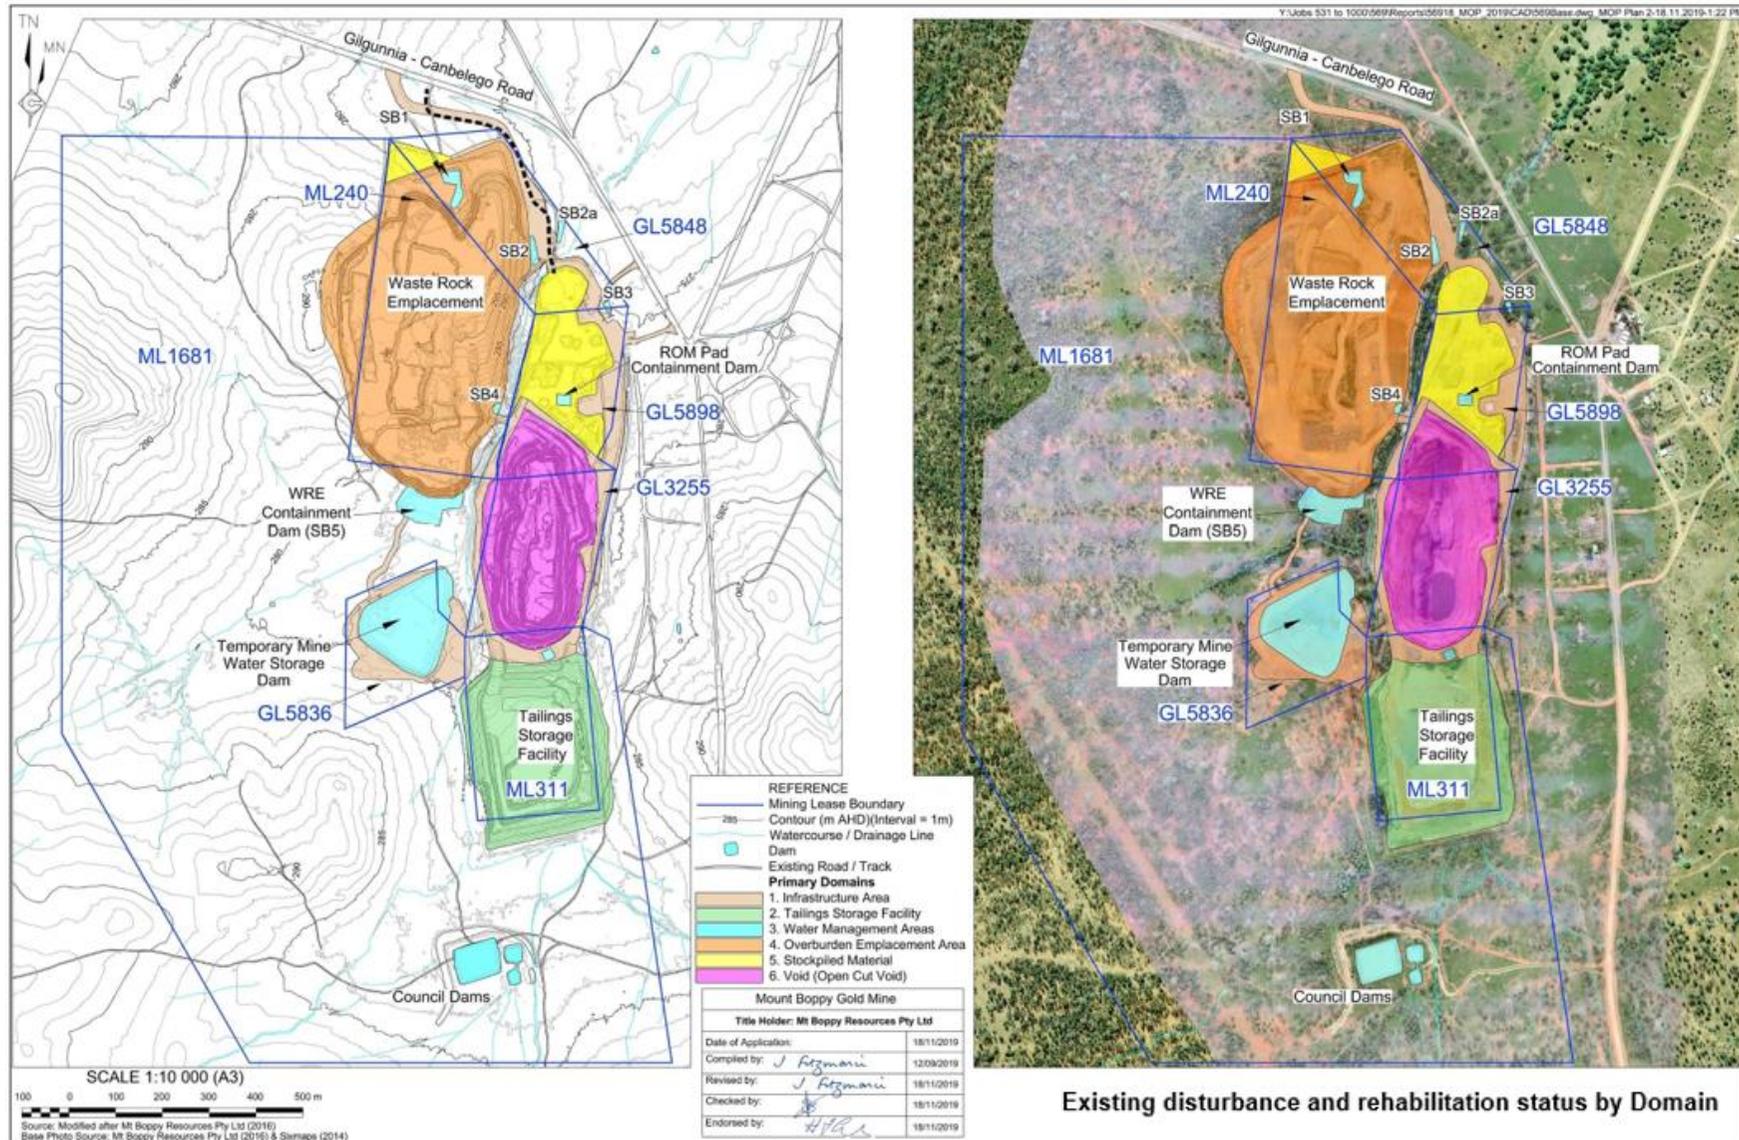
Figure 6. Mt Boppy Domains, existing disturbance and rehabilitation status as at end of reporting period.
