REHABILITATION REPORT

19 January 2019 to 18 January 2020

Wonawinta Silver Project

Manuka Silver Mine

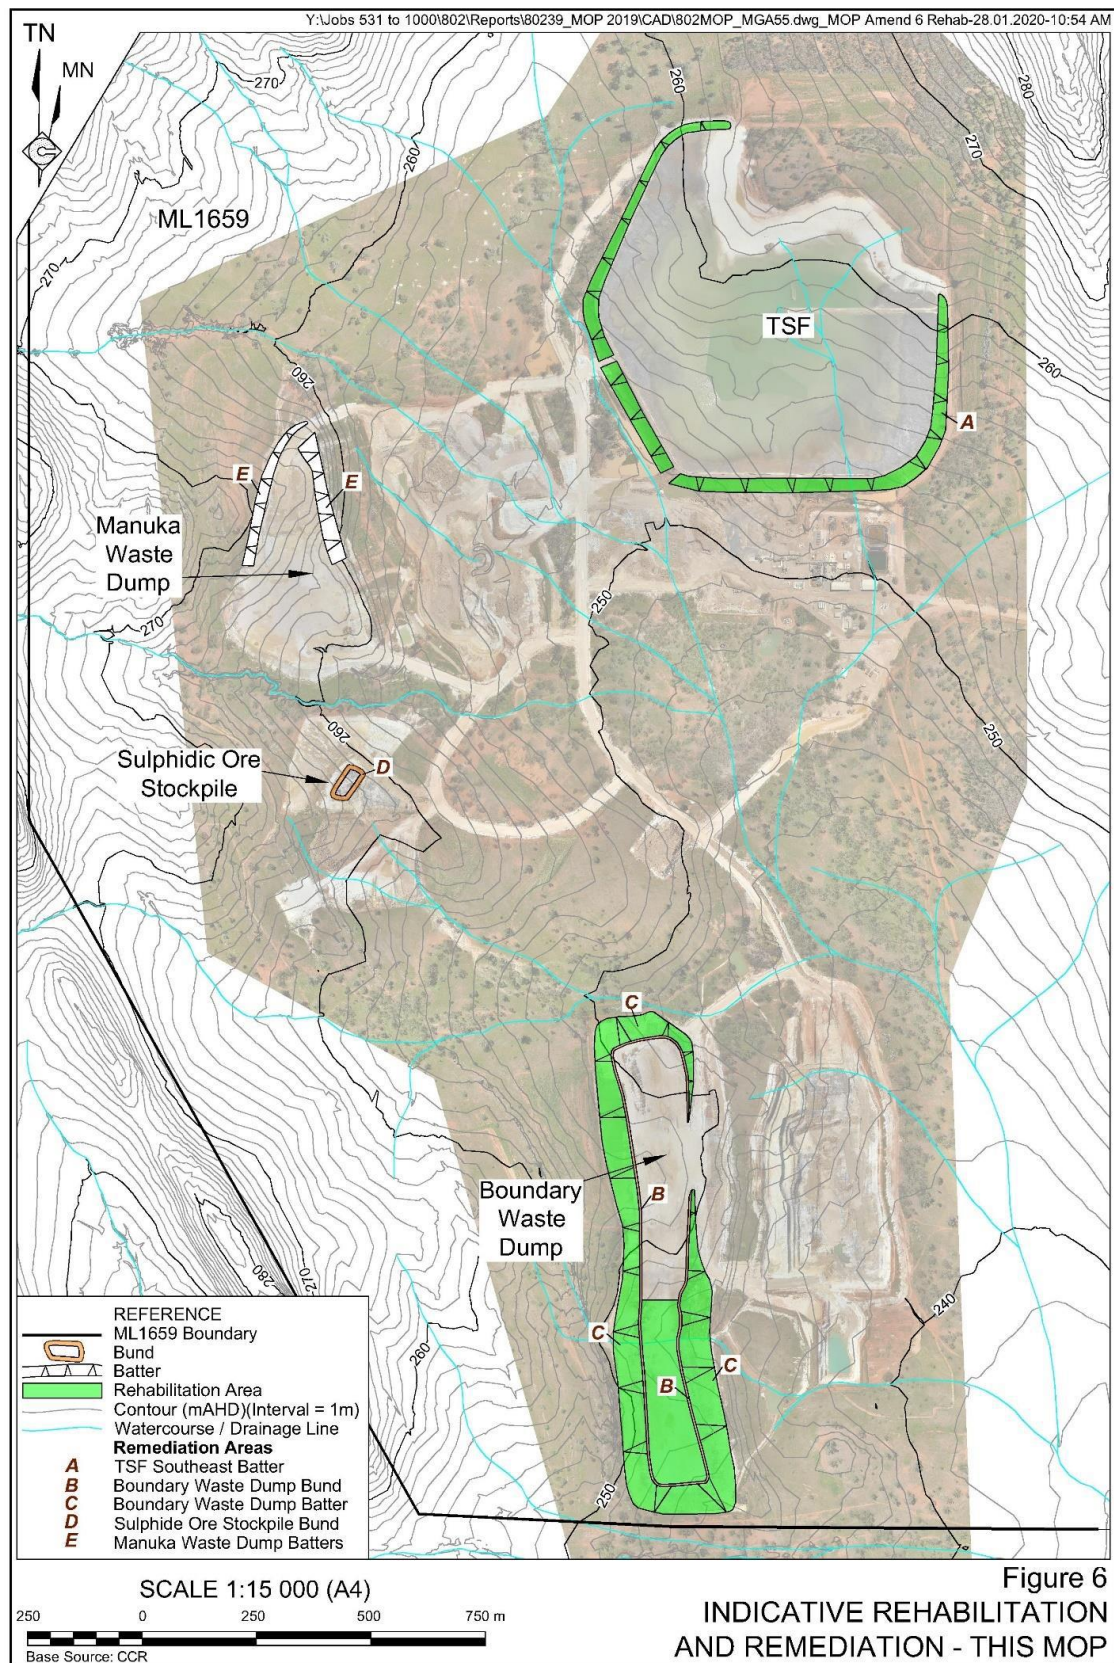
Figure 6: Rehabilitation and Remediation focus areas for 2020 – 2021 MOP period

Erosion has been noted on the southeast corner of the TSF. This has not significantly changed over the reporting period due to the limited rainfall. Now that there are personnel and earthmoving equipment mobilised on the site, this problematic area will be reprofiled and stabilised in the first quarter of 2020. A surveillance and monitoring program will be implemented to ensure early identification and rectification of erosion on the TSF batters.

Figure 6 below shows the areas of focus for battering and remediation over the 2020 – 2021 MOP period. Area A includes this TSF erosion rectification works that will take place in this reporting period.

- Operation of and further development of the above ground TSF, capable of containing up to 1.5Mt of tailings.
- Progressive rehabilitation of the walls of the TSF, including repair of erosion on the southeast corner of the TSF wall.

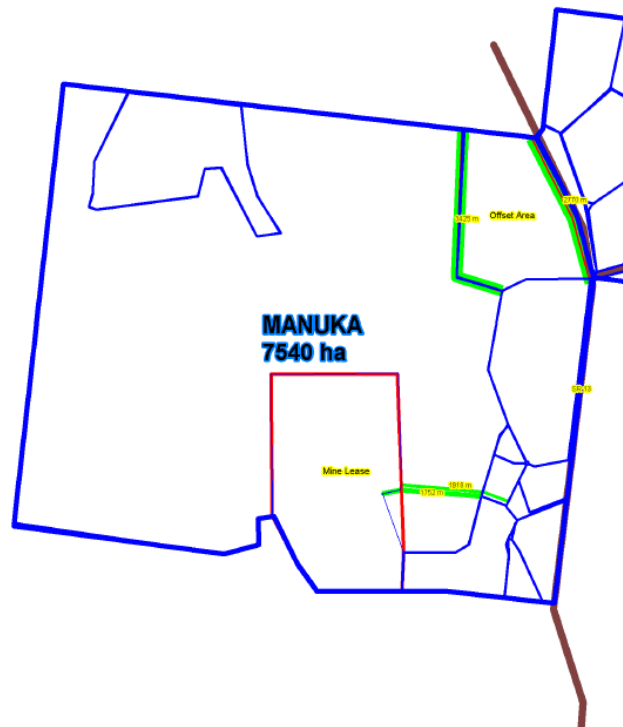
During the period August 2019 to January 2020 new fencing was erected on Manuka mining lease to repair/replace exiting fencing which was in poor condition and allowing animals to stray onto the ML boundary. Areas which were repaired are shown in **Figures 7a - d** below. This area comprises the road between the camp and the plant and the eastern and western boundaries of the biodiversity offset area to the NE of the pastoral lease.

Figure 7a Location of new fencing is highlighted in GREEN.

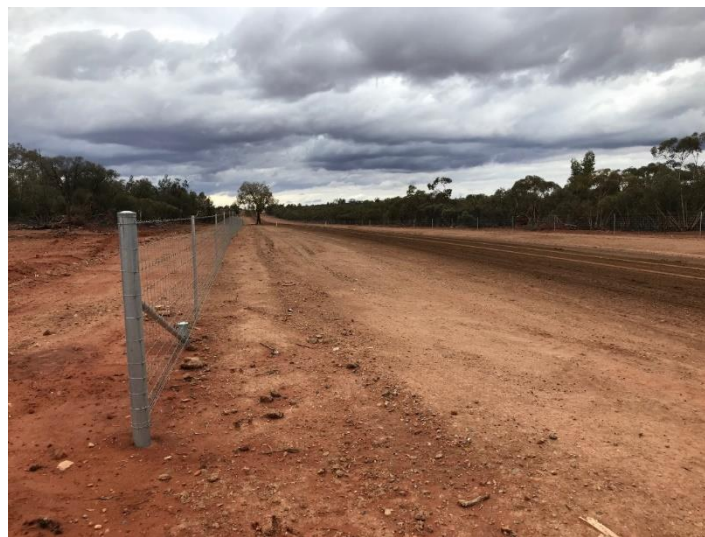
Figure 7b Road between camp and plant

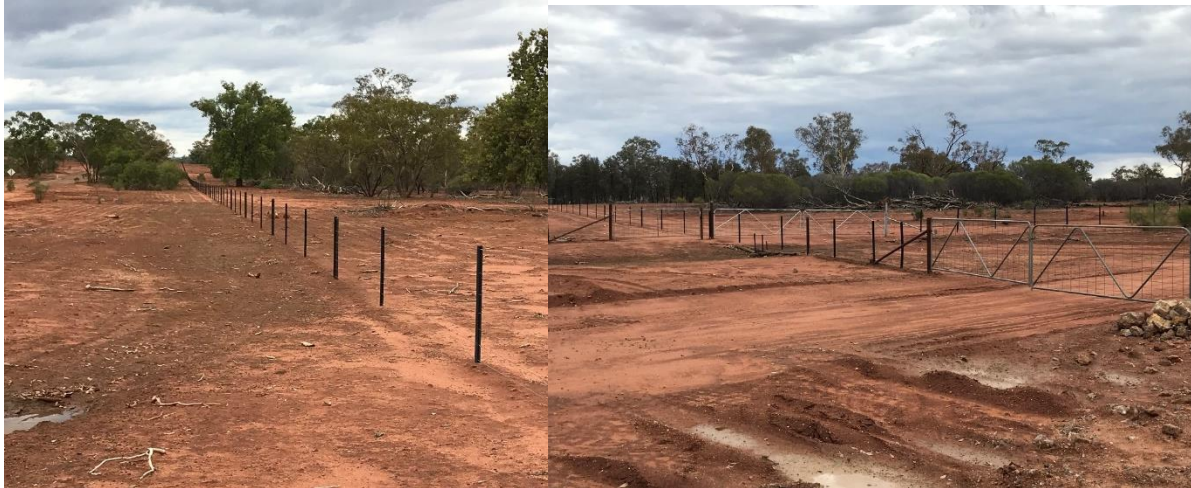
Figure 7c Manuka Rd leaving site

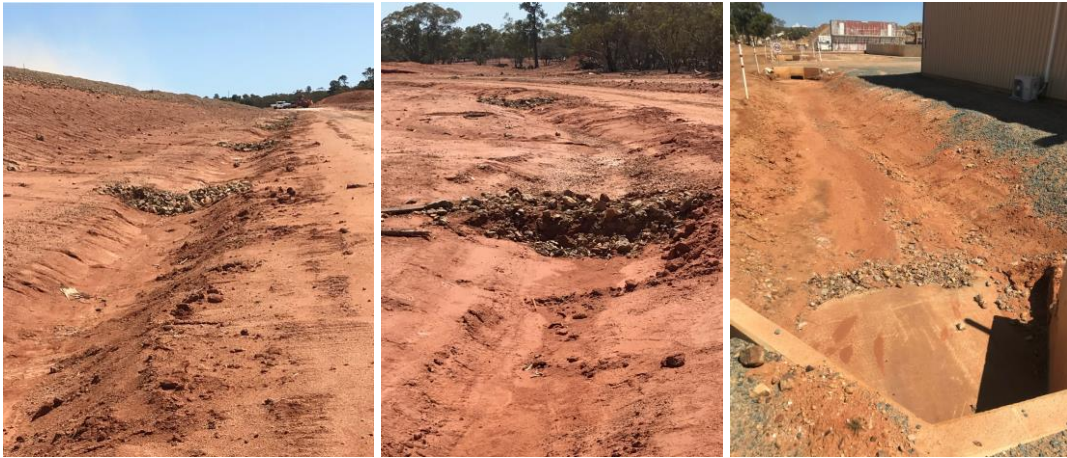
Figures 10 a) and b) **TSF run off drain repairs** and c) **Stormwater drain re-establishment around Plant**

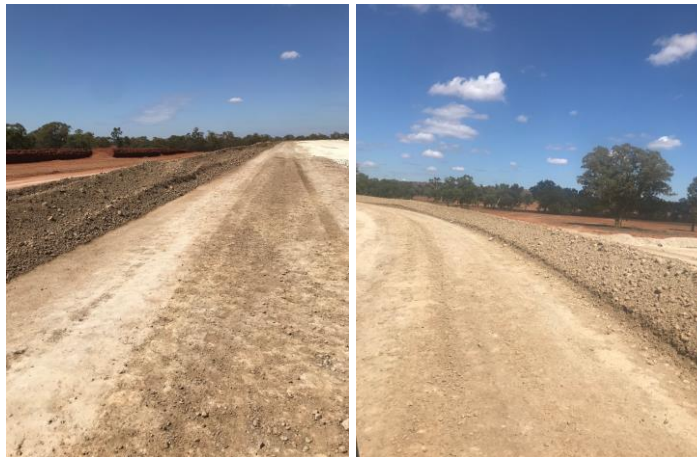
Figures 10 d) and e) **TSF windrow repairs**

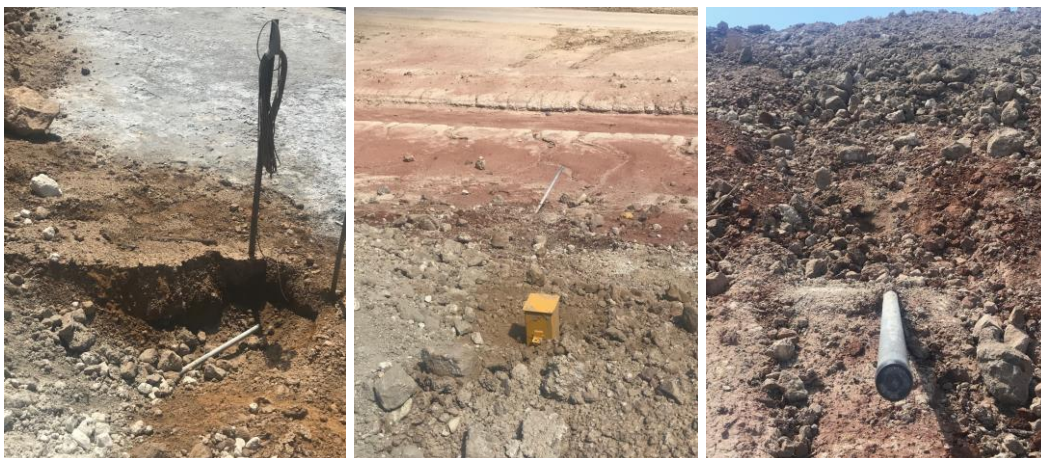
Figures 10 f) g) and h) **TSF piezometer repairs**
