# ANNUAL REHABILITATION REPORT

## 1 February 2021 to 31 January 2022

Mt Boppy Gold Mine  
Canbelego, NSW

Document ID: MRL-ENV-RPT-002.2022.002

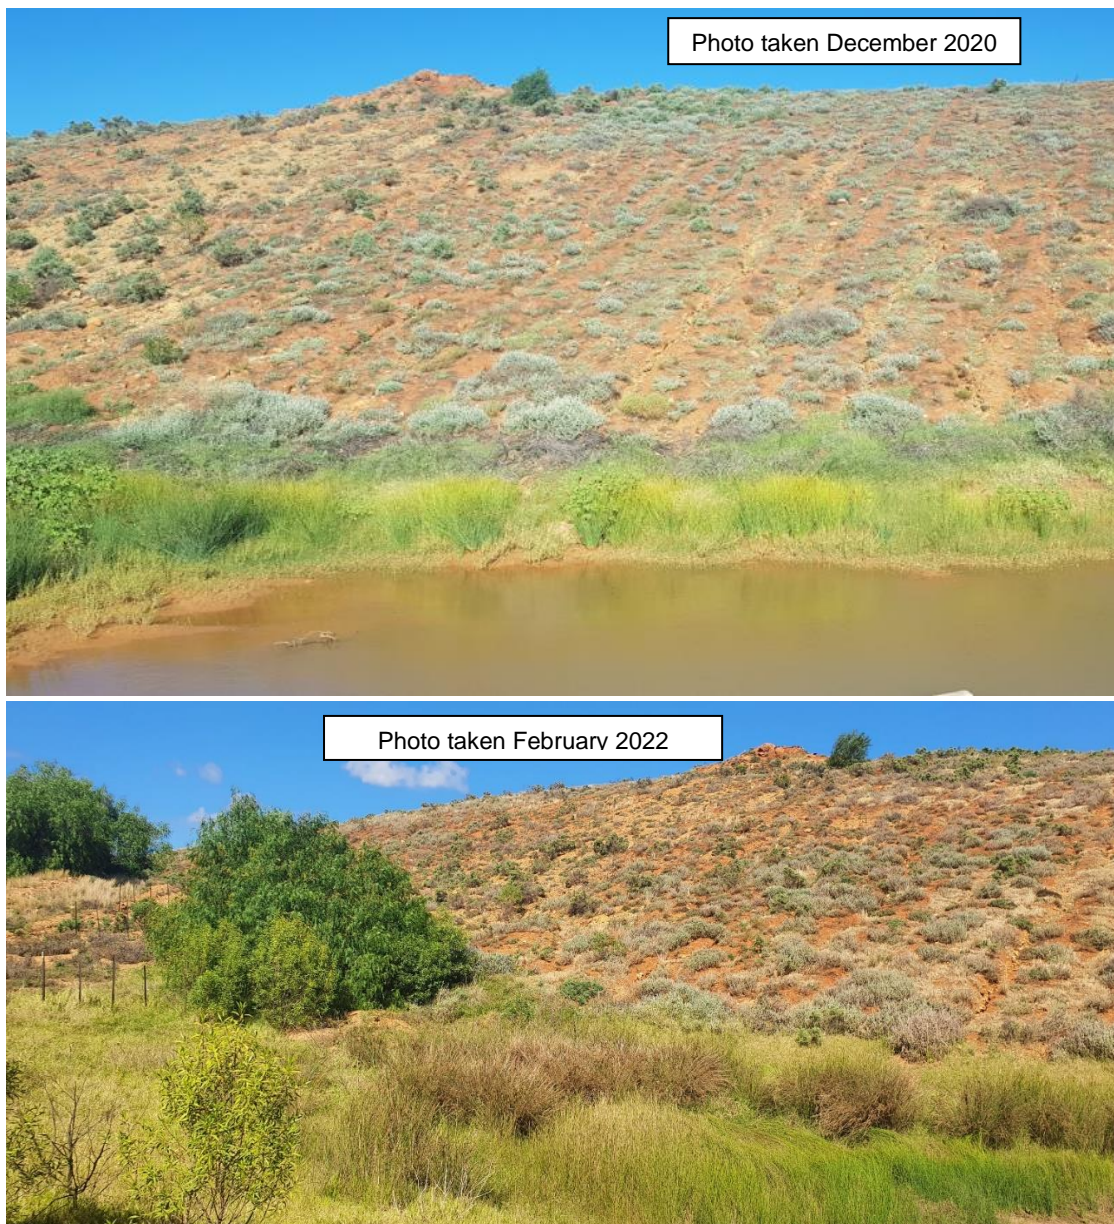
**Figure 3: Comparative photos of the Eastern bank of the waste rock emplacement showing progress of groundcover species growth and minimal erosion.**

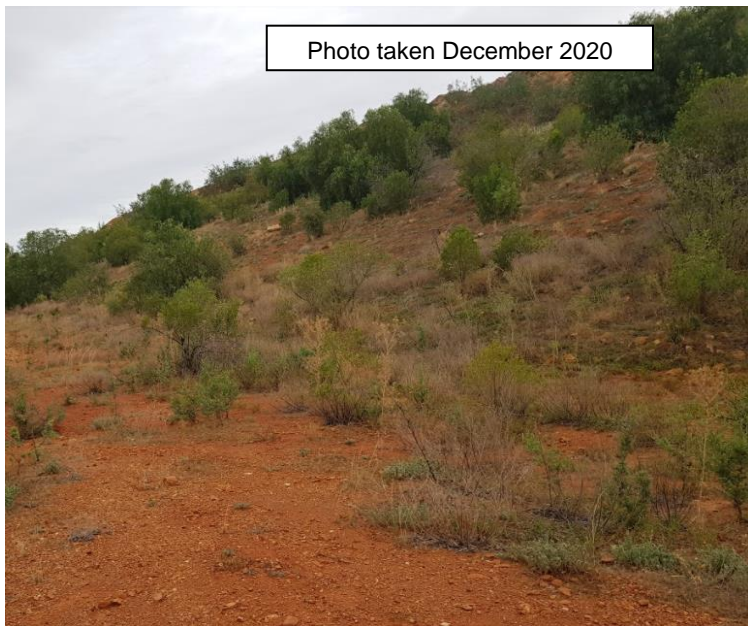
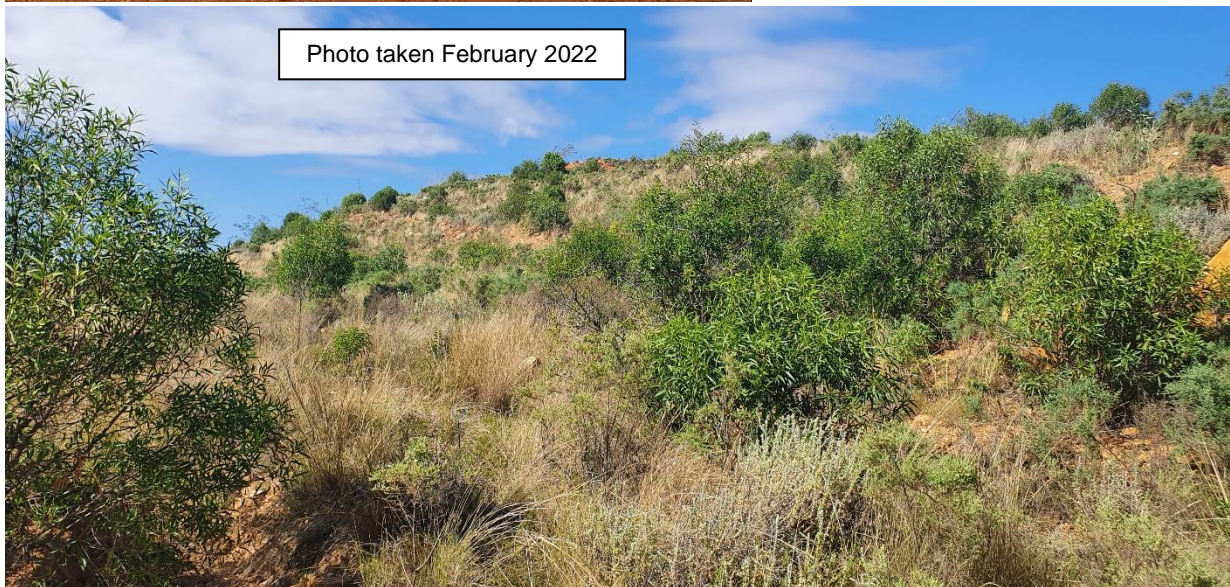
**Figure 4: Western side of the TSF embankment with established groundcover.**

**Figure 4** shows a section of the western embankment of the TSF which has achieved ground cover levels consistent with natural surrounds. The comparative photos of December 2020 and February 2022 demonstrate the progressive groundcover growth on the western side of the TSF and resisted erosion despite the heavy rainfall the Upper Western Region has experienced between 2020 and early 2022. Inspections have discovered minimal erosion and continued flora growth providing a good indication that a sustainable stable landform will be achieved when the embankment is profiled to meet slope angles consistent with the final landform designs.

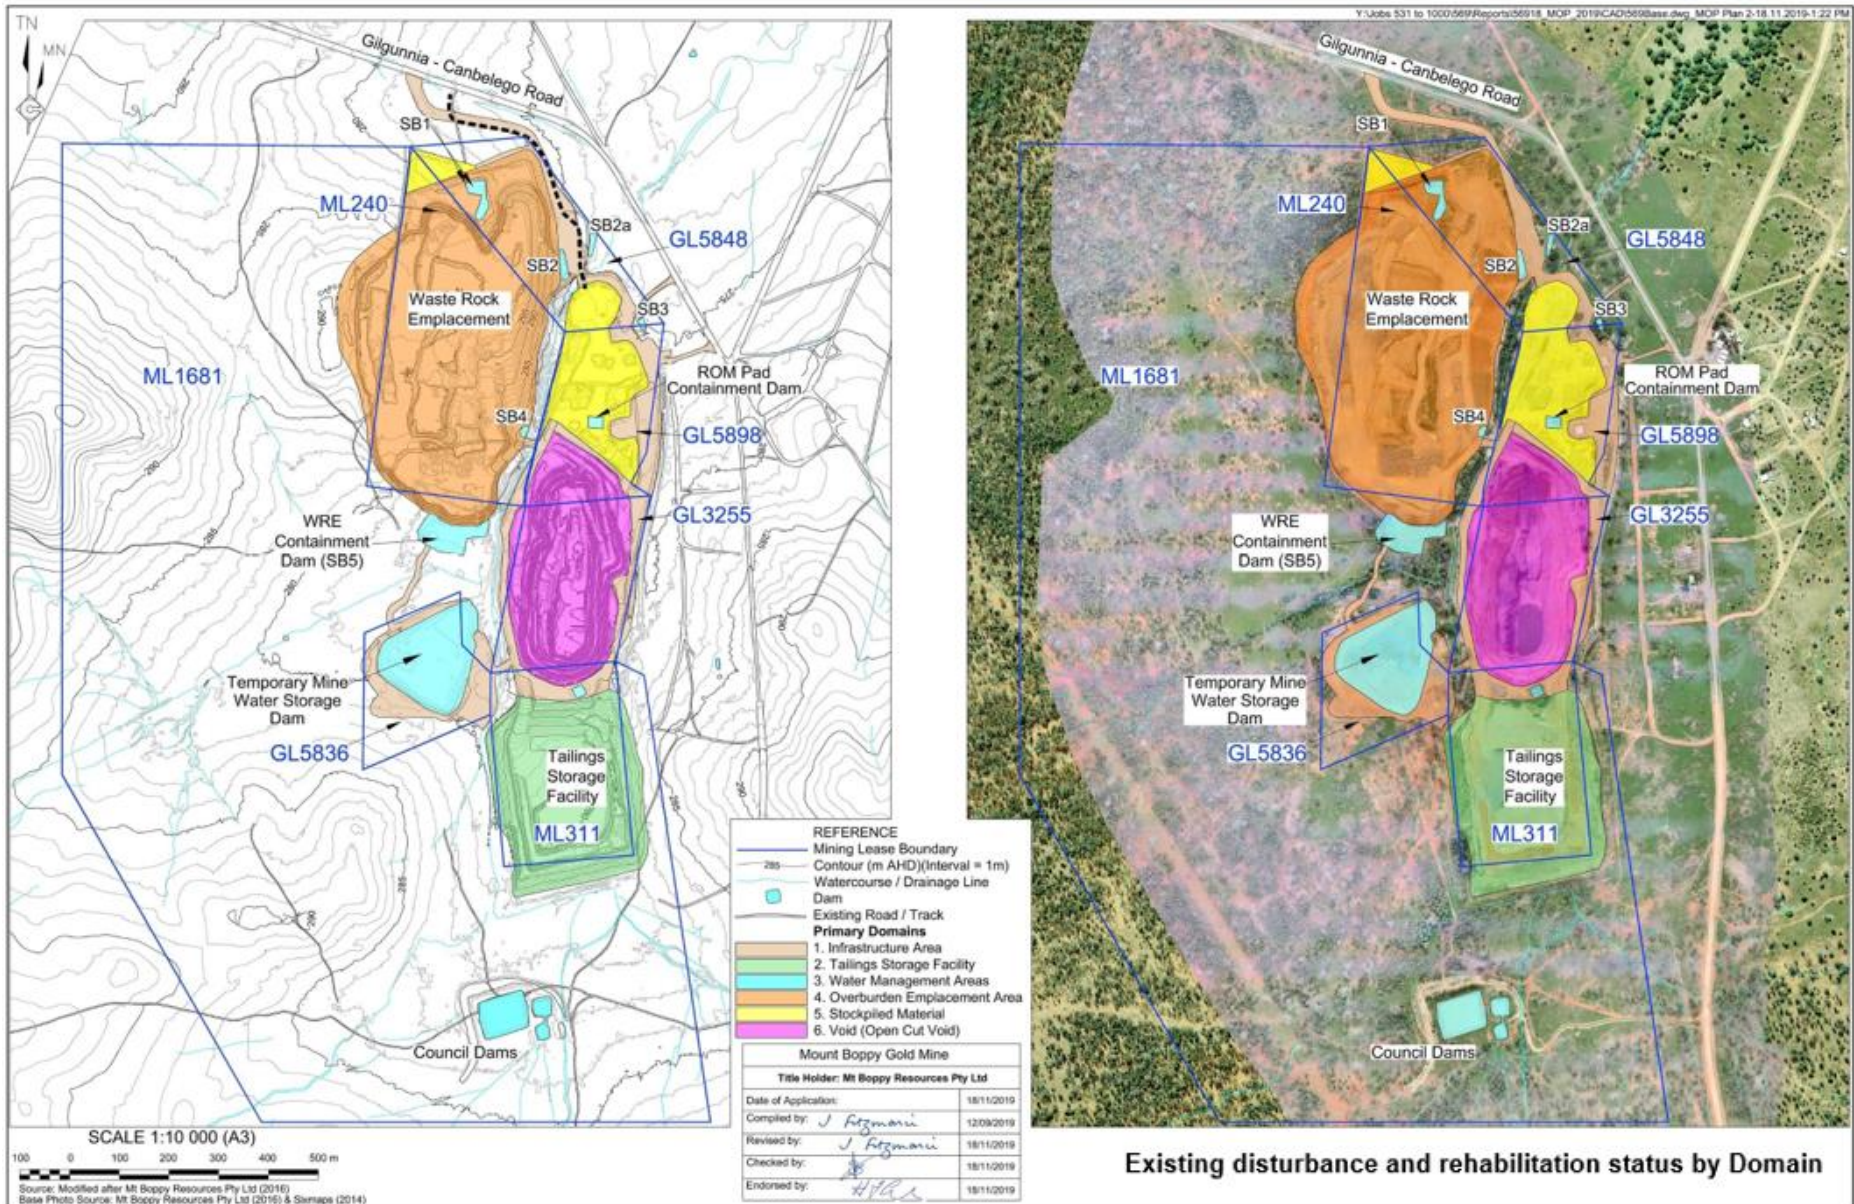
**Figure 5: Mt Boppy Domains, existing disturbance, and rehabilitation status**
