**REHABILITATION  
MANAGEMENT PLAN**

Mt Boppy Gold Mine

Prepared by  
Umwelt (Australia) Pty Limited  
on behalf of  
Manuka Resources

Project Director: Alex Irwin  
Project Manager: Alex Irwin  
Report No. 22549/R01  
Date: August 2022

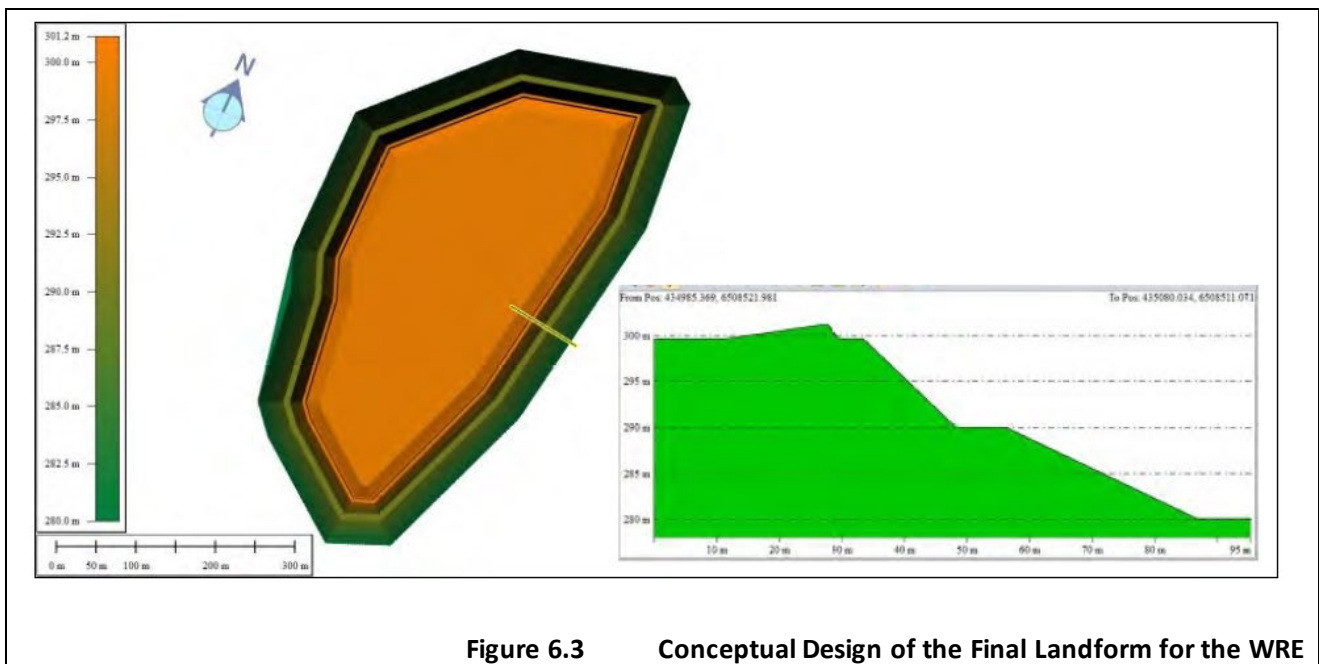
**Figure 6.3 Conceptual Design of the Final Landform for the WRE**

No demolition activities are relevant to this domain. Backfill of the open cut void is not practical or economic and will be retained. however, design of the void (see **Figure 6.3**) provides for a stable structure, with highwall slope no greater than 70°, which will not require ongoing management.

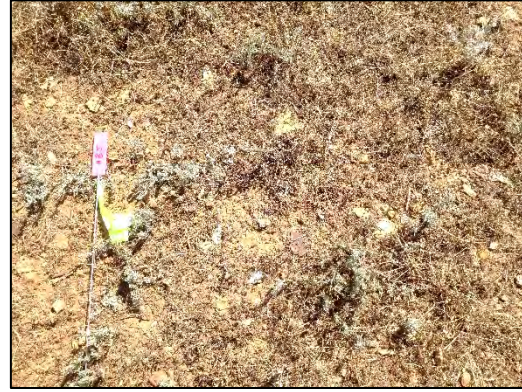
**Photograph 2.** Ground condition of natural ground at Site MB05. Surface coarse fragment content was 10-20 %.

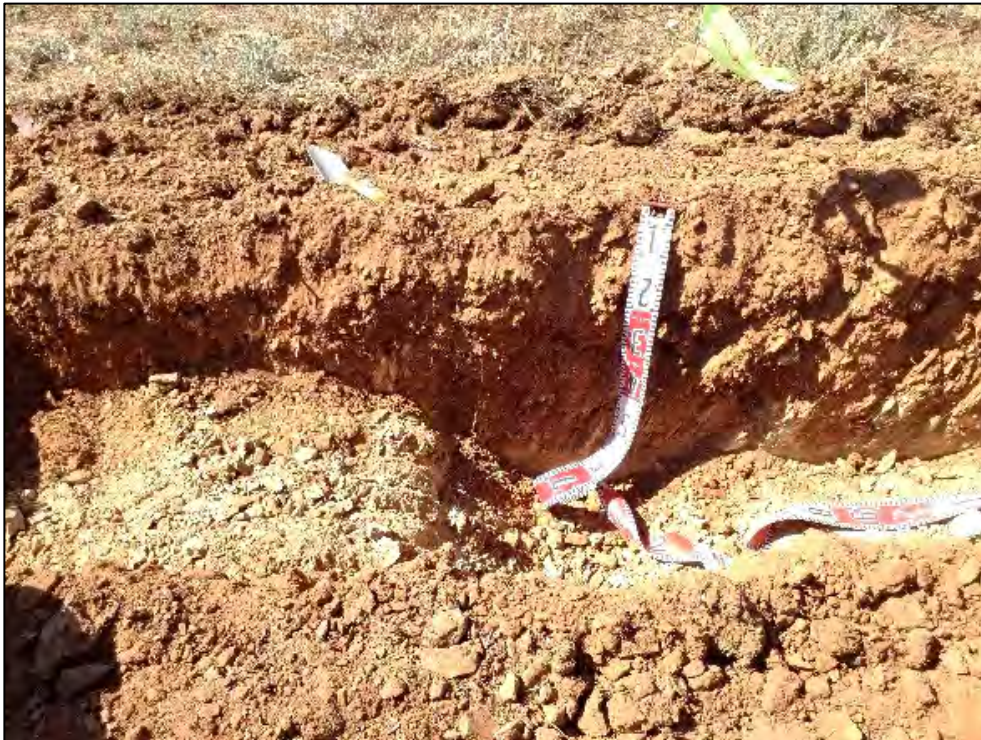
**Photograph 3.** Soil profile of natural ground to the west of WRE (Site CD5-01). Soil profiles in this area contained appreciable gravel content.

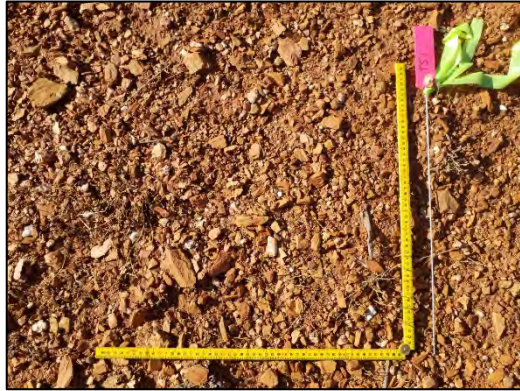
**Photograph 5.** Gravelly Topsoil stockpile (Site TS1) in an armored condition from rainfall.

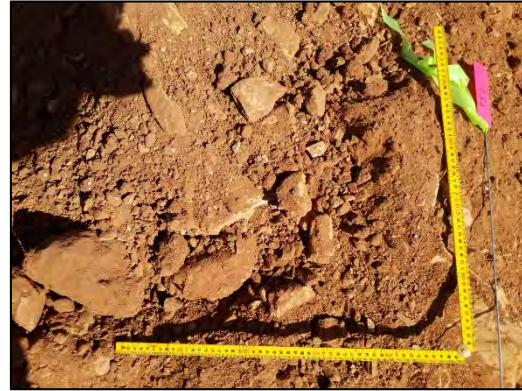
**Photograph 6.** Gravelly Topsoil stockpile (Site TS1) is newly disturbed.

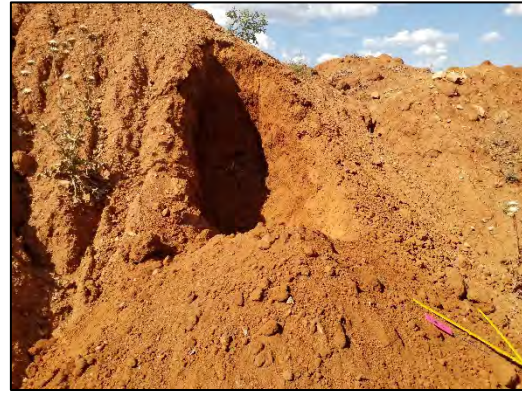
**Photograph 11.** Non-Gravelly Topsoil stockpile (Site TS14) newly disturbed.

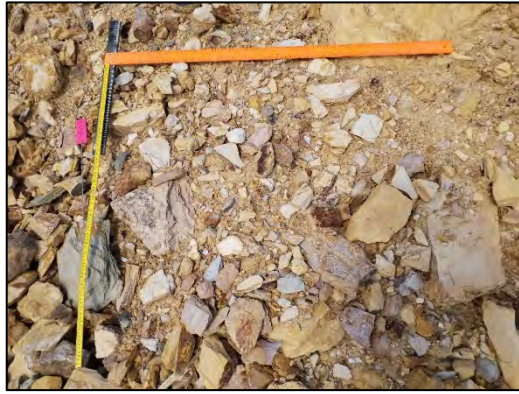
**Photograph 13.** Waste Rock Oxide material (Site WRO1) in an armored condition from rainfall.

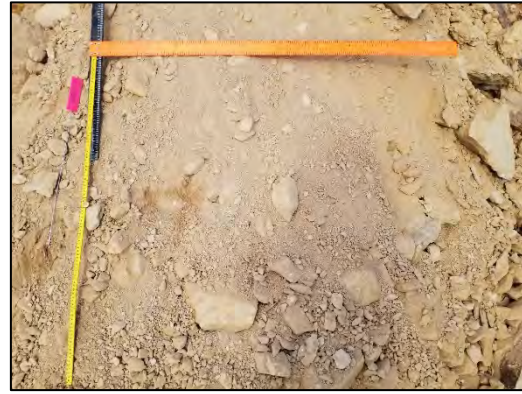
**Photograph 14.** Waste Rock Oxide material (Site WRO1) newly disturbed.

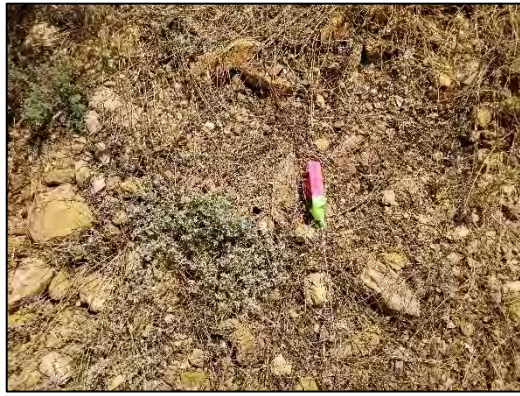
**Photograph 15.** Rehabilitated Waste Rock Oxide (Site WRO1) with vegetation and in an armored condition from rainfall.

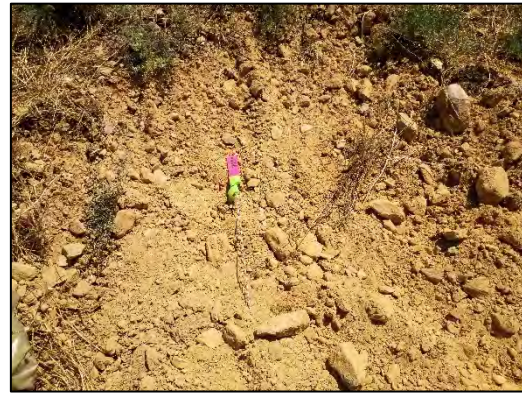
**Photograph 16.** Rehabilitated Waste Rock Oxide (Site WRO1) newly disturbed.

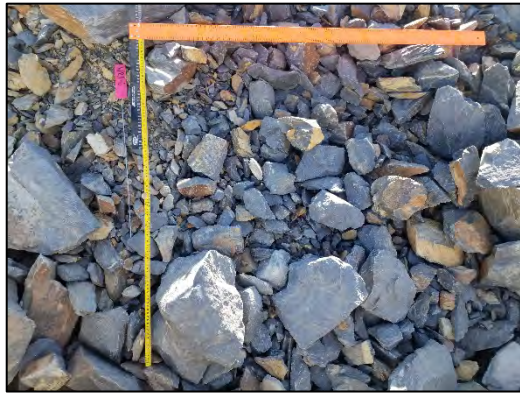
**Photograph 17.** Fresh Waste Rock material (Site WRF6) in an armored condition from rainfall.

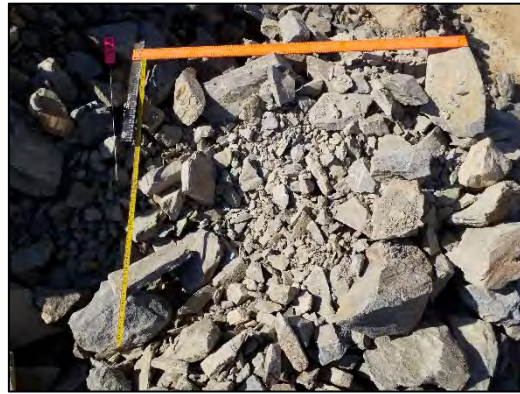
**Photograph 18.** Fresh Waste Rock material (Site WRF6) newly disturbed.

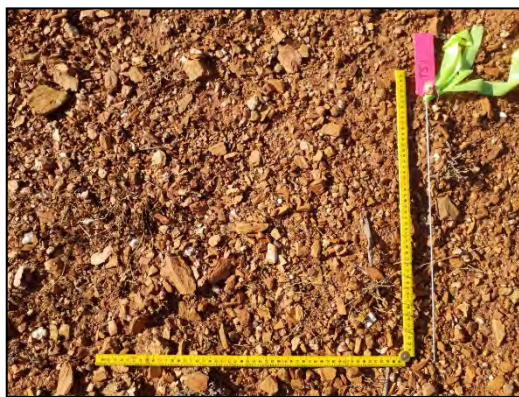
**Photograph 1.** Gravelly Topsoil stockpile in an armored condition from rainfall. Rock coverage of armored surface is 45–75 %.

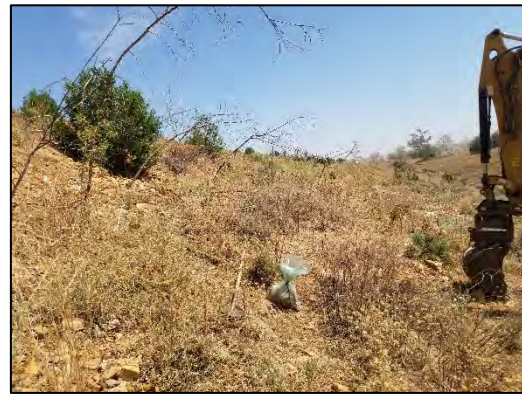
**Photograph 8.** Rehabilitated Waste Rock Oxide batter. Plants consisted of grasses, forbs, and shrubs that provided more than 80 % groundcover (surface contact) from vegetation.

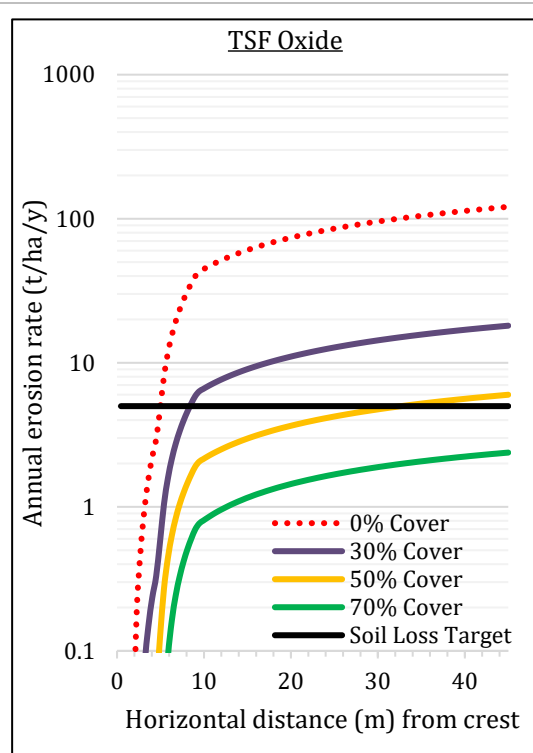
**Figure 10.** TFS Waste Rock Oxide: Soil loss target was achieved at approximately 55 % surface cover.

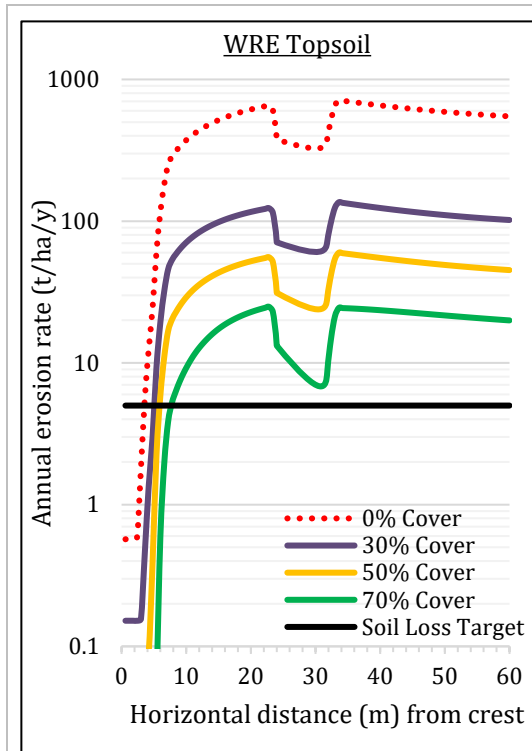
**Figure 11.** WRE Gravelly Topsoil: Soil loss target was exceeded for all cover conditions assessed.

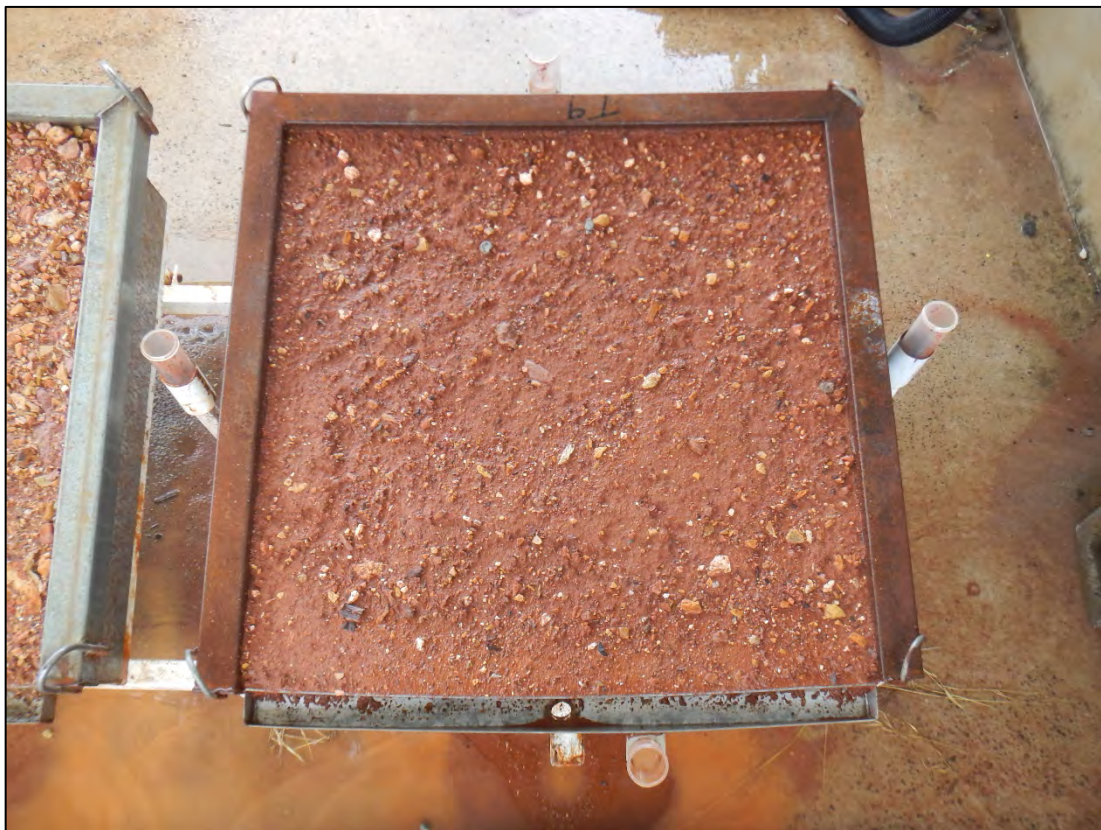
**Photograph 14.** Gravelly Topsoil test plot after receiving simulated rain at 125 mm/hr.

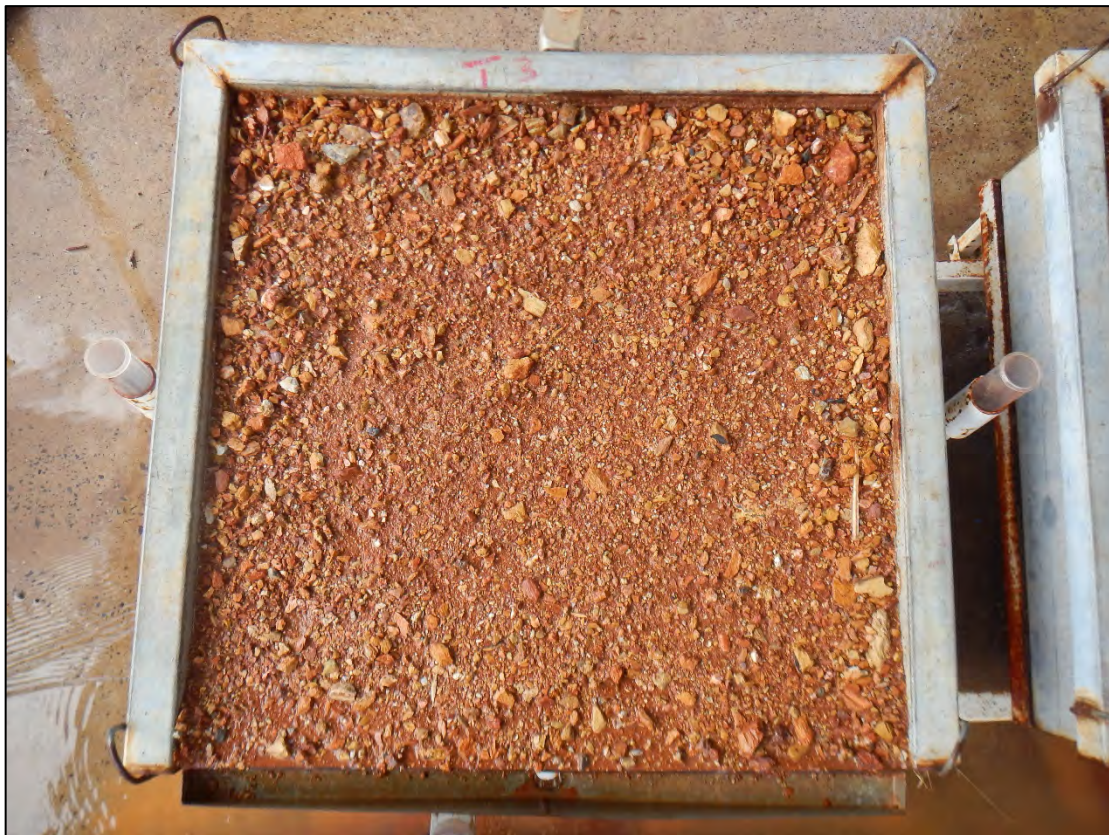
**Photograph 16.** Waste Rock Oxide test plot after receiving simulated rain at ~125 mm/hr..

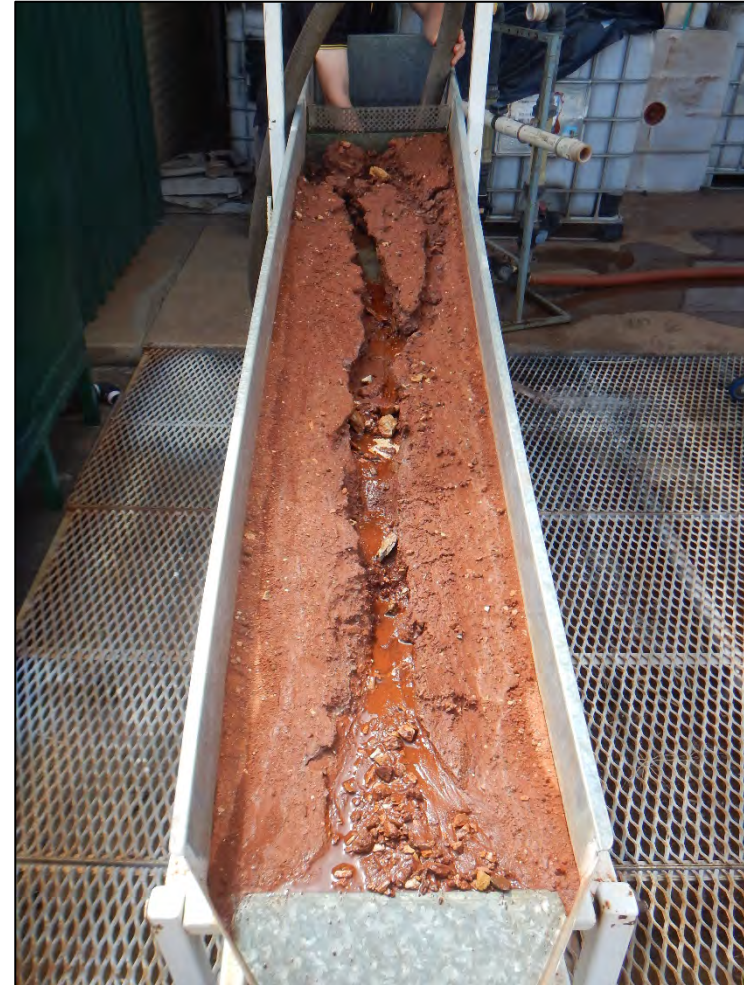
**Photograph 18.** Gravelly Topsoil plot tested to failure with overland flows.

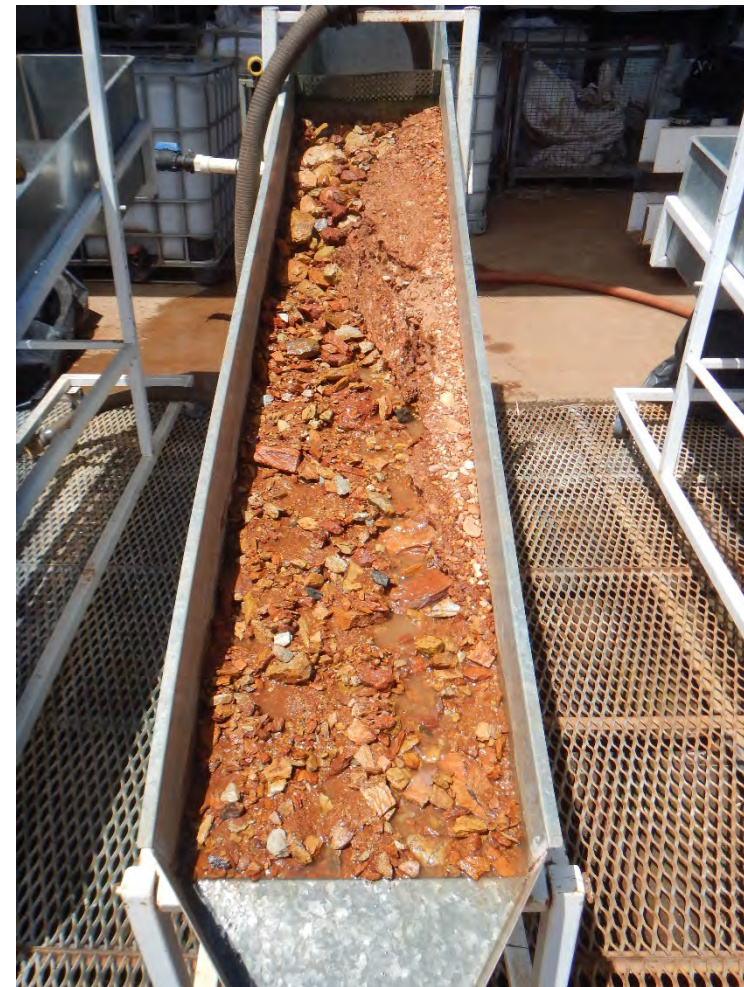
**Photograph 20.** Waste Rock Oxide plot tested to failure with overland flows.
