ANNUAL REHABILITATION REPORT

Wonawinta Silver Project

Document ID: MRL-ENV-RPT-002-2022.001

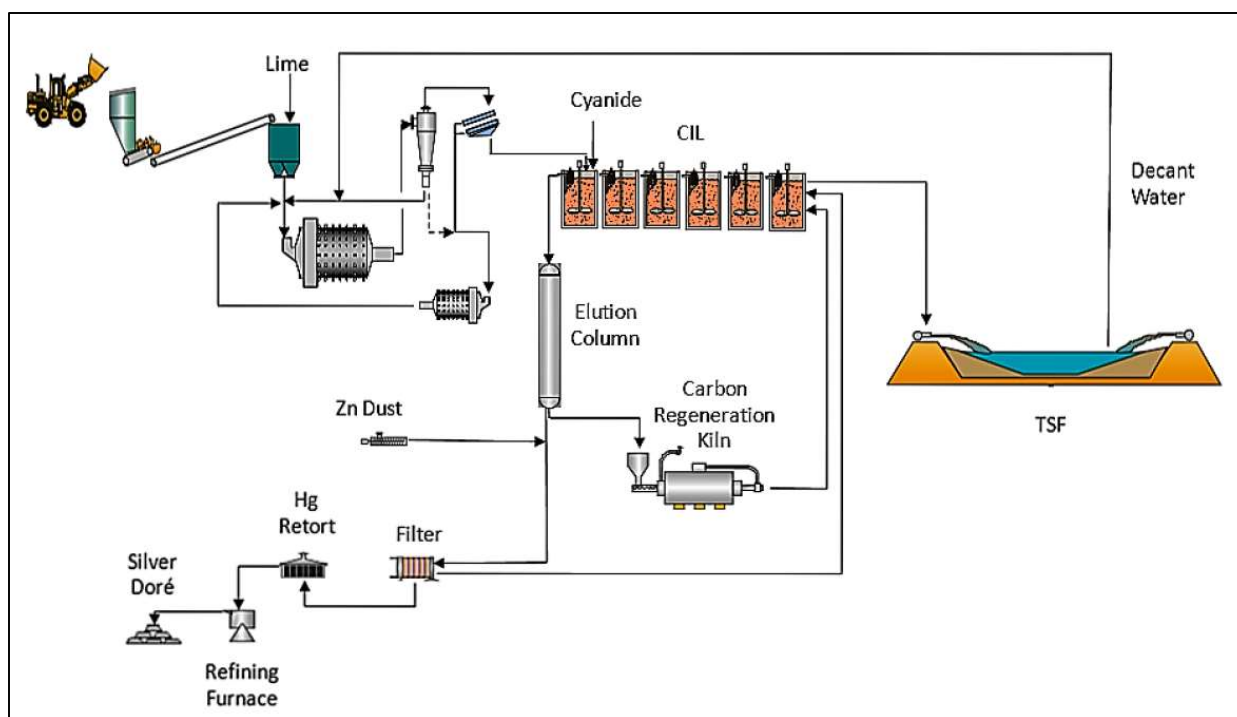
Figure 6: Gold Processing Flow Chart for the Mt Boppy Ore at Wonawinta Silver Project.

The processing operations for the Mt Boppy ore utilise the same carbon-in-leach processing methodology as the approved processing operations. **Figure 6** below presents the processing flow chart for processing of the Mt Boppy ore. Processing of Mt Boppy ore ceased at February 2022.

A mineral processing plant is located at the Wonawinta Silver Project, including feed preparation, carbon-in-leach circuit, carbon regeneration and Merrill process (mercury removal and silver smelting). The processing plant was decommissioned and cleaned out in early 2016 and was refurbished over 2019 and 2020 to allow for the processing of imported Mt Boppy gold ore. Plant works were commissioned, and the first ore was processed in April 2020.

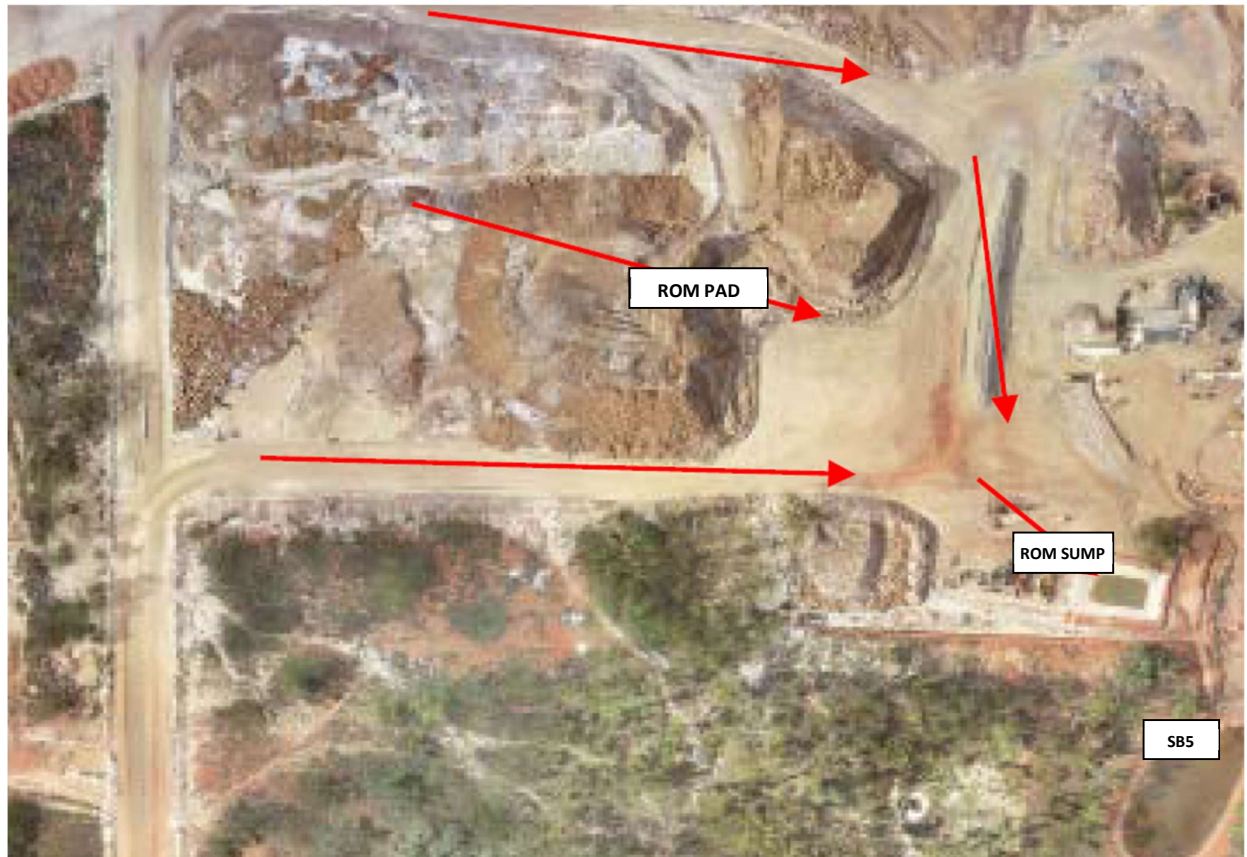
Works were completed in late 2021, and the rainfall experienced on site since has demonstrated the drainage and catchment pond works in line with expectations. The direction of expected water flow is indicated on **Figure 9** below.

Figure 9: ROM Pad showing direction of surface water run-off toward the new ROM Sump.

The ROM pad drainage and water catchment systems have been generally reviewed in line with the Wonawinta Surface Water Management Plan. Earthworks have been undertaken to reinstate drains, upgrade a catchment pond and reinstate water management structures, such as windrows and cut-off drains.

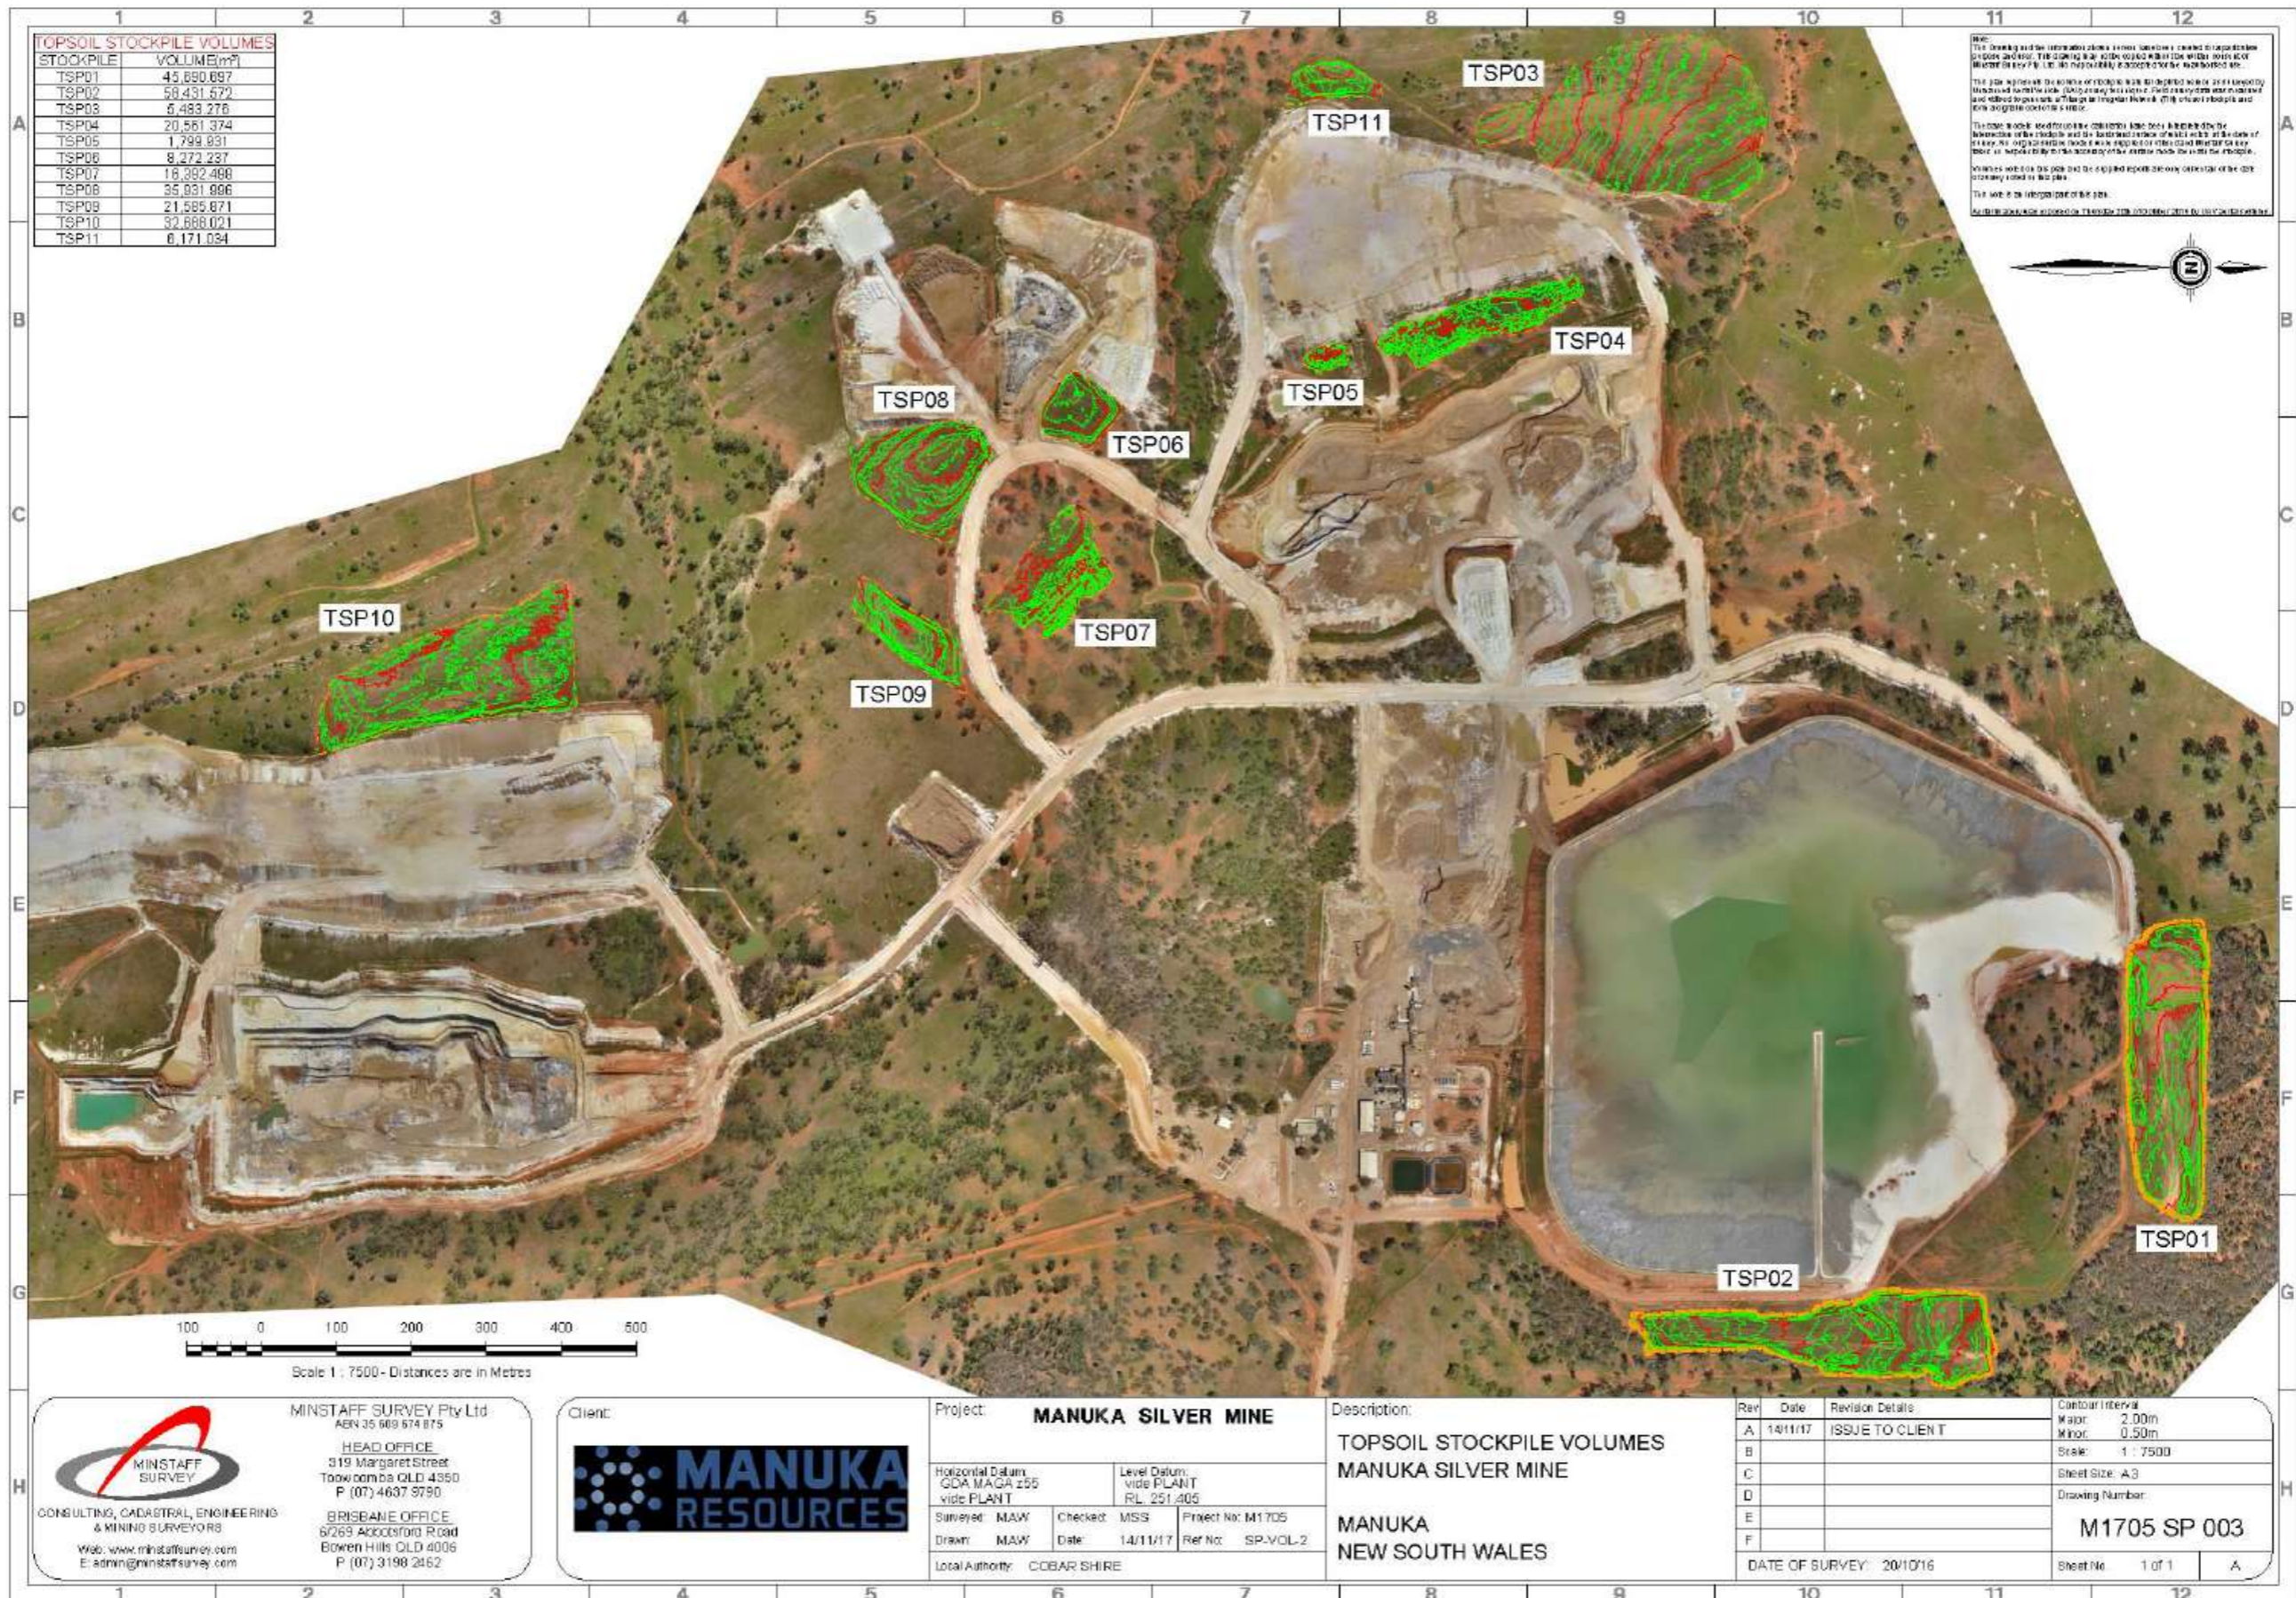
Figure 11: Topsoil Stockpile Volumes at Wonawinta Silver Project surveyed on 10/10/16 (Dwg No. M1705-SP003 Rev A)

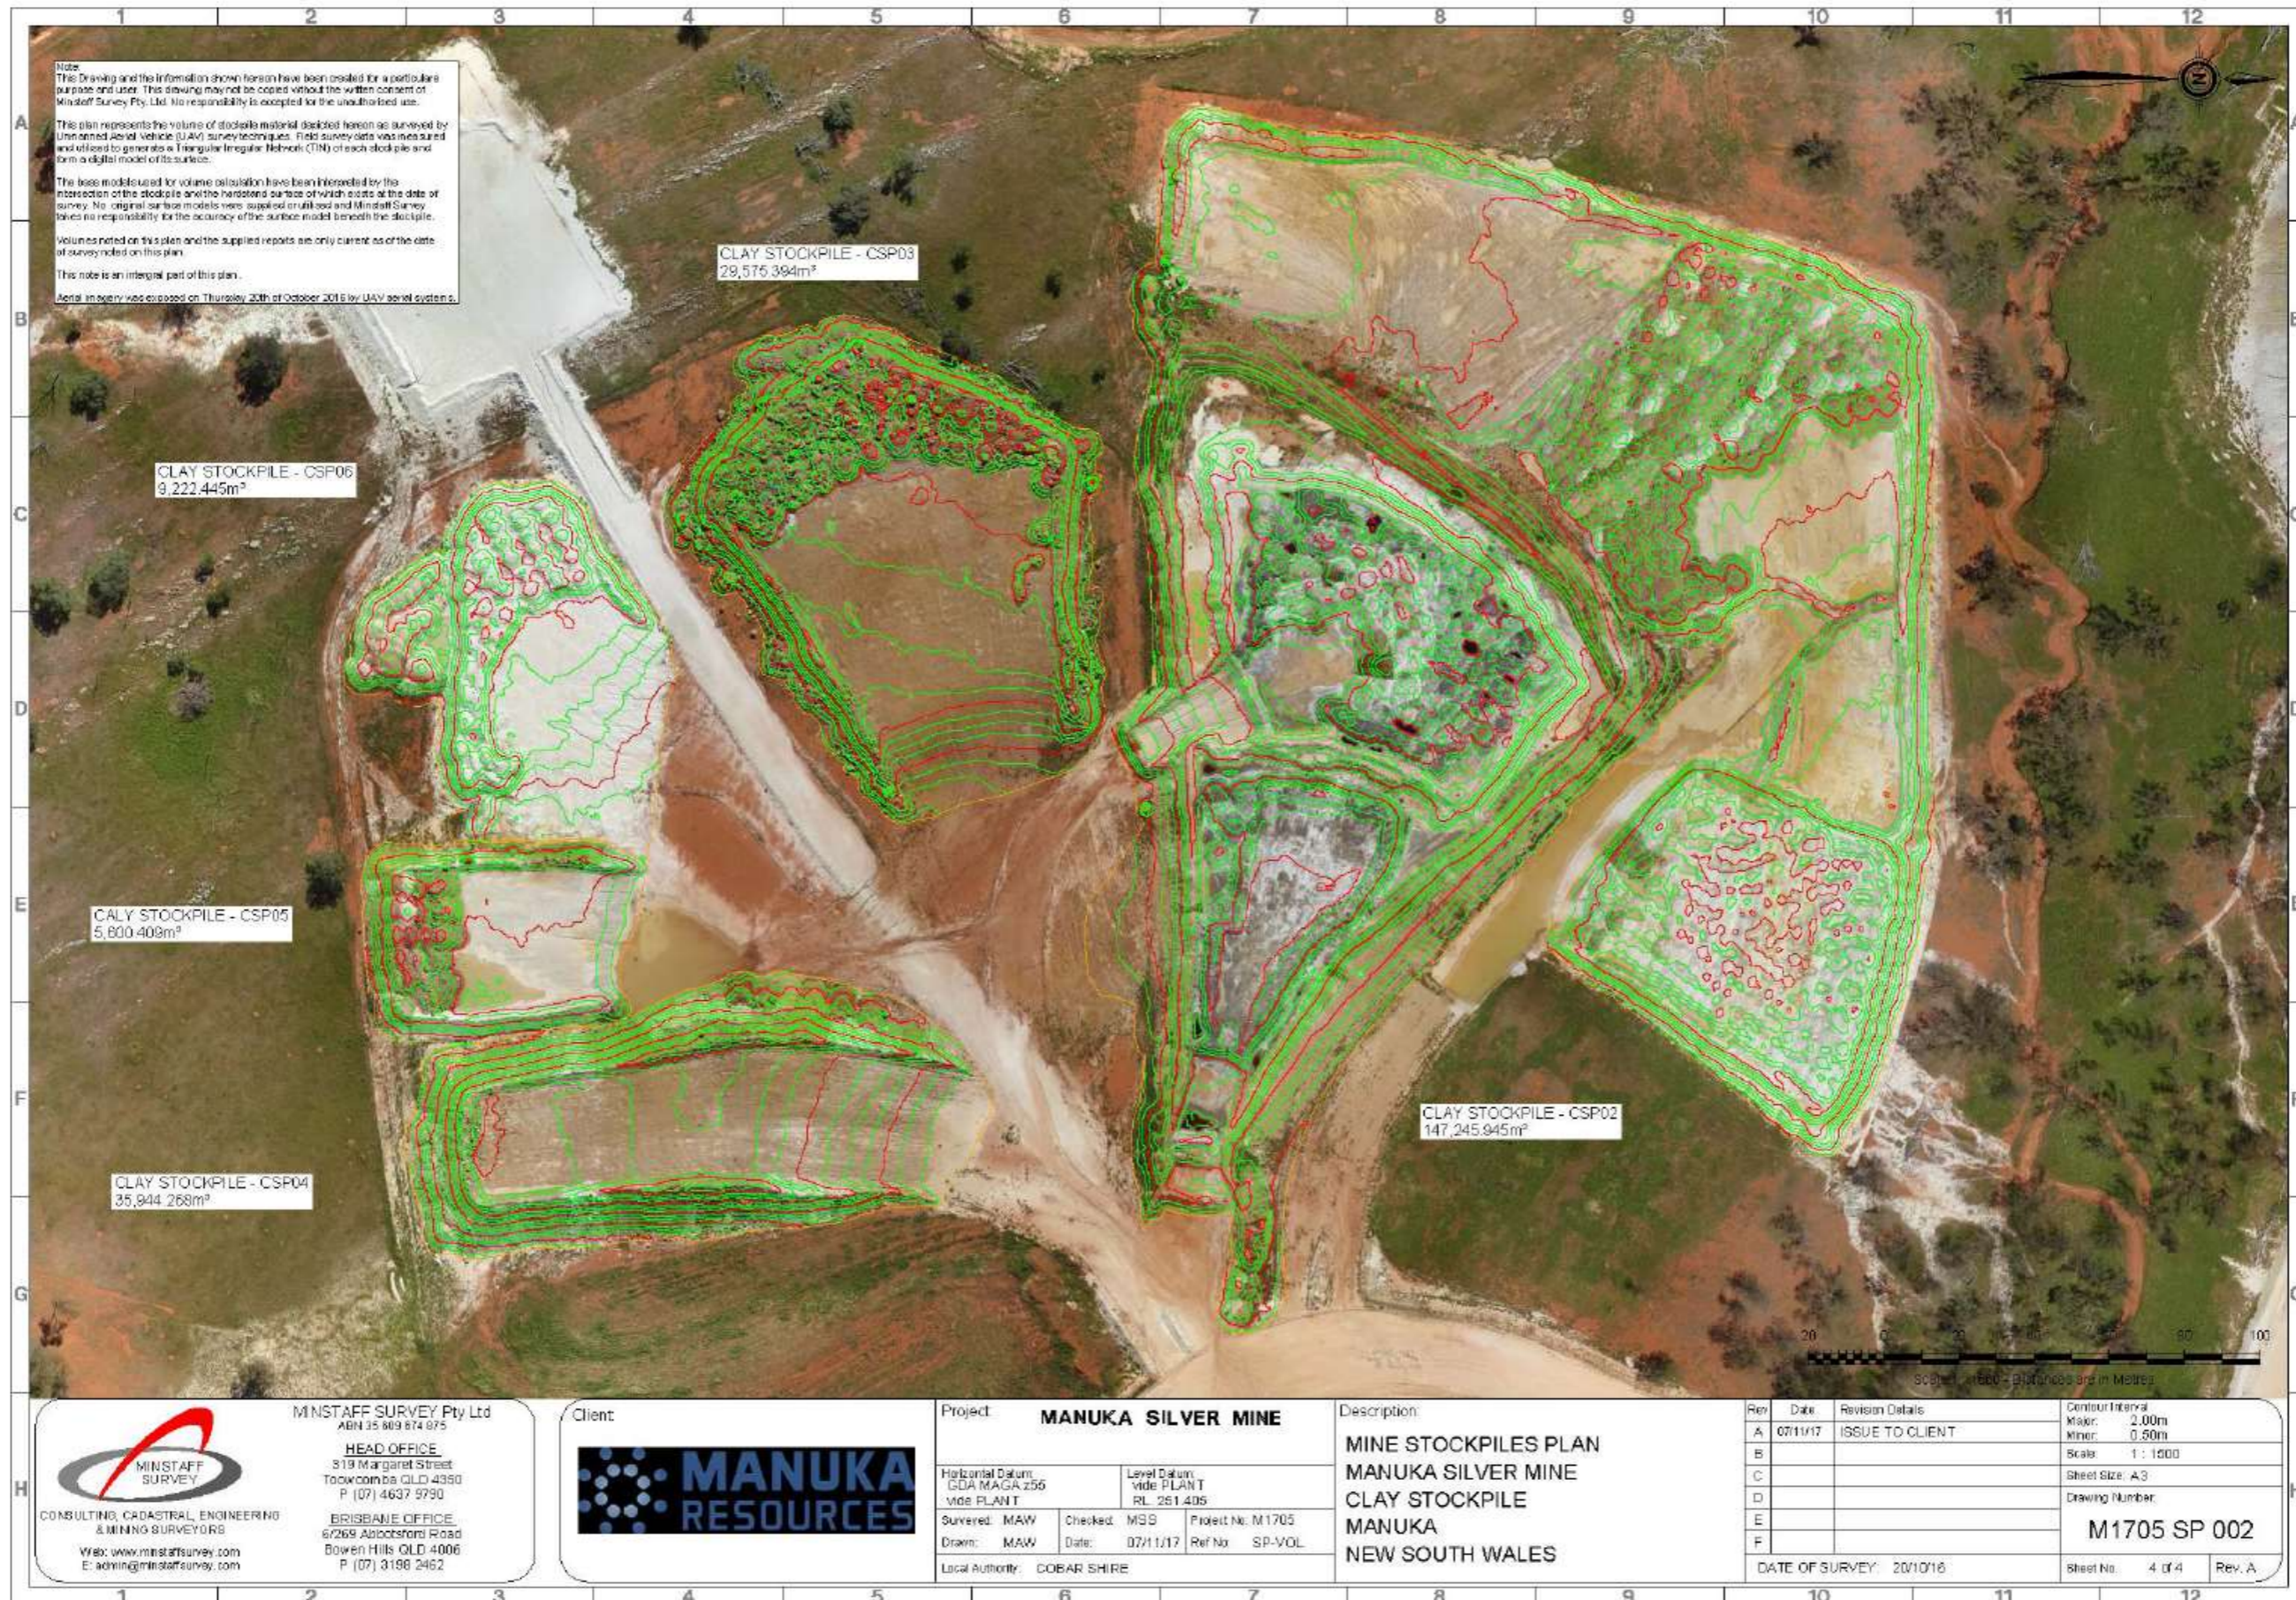
Figure 14: Clay Stockpile at Wonawinta Silver Project surveyed on 10/10/16 (Dwg No. M1705-SP002 Rev A, Sheet no. 4)

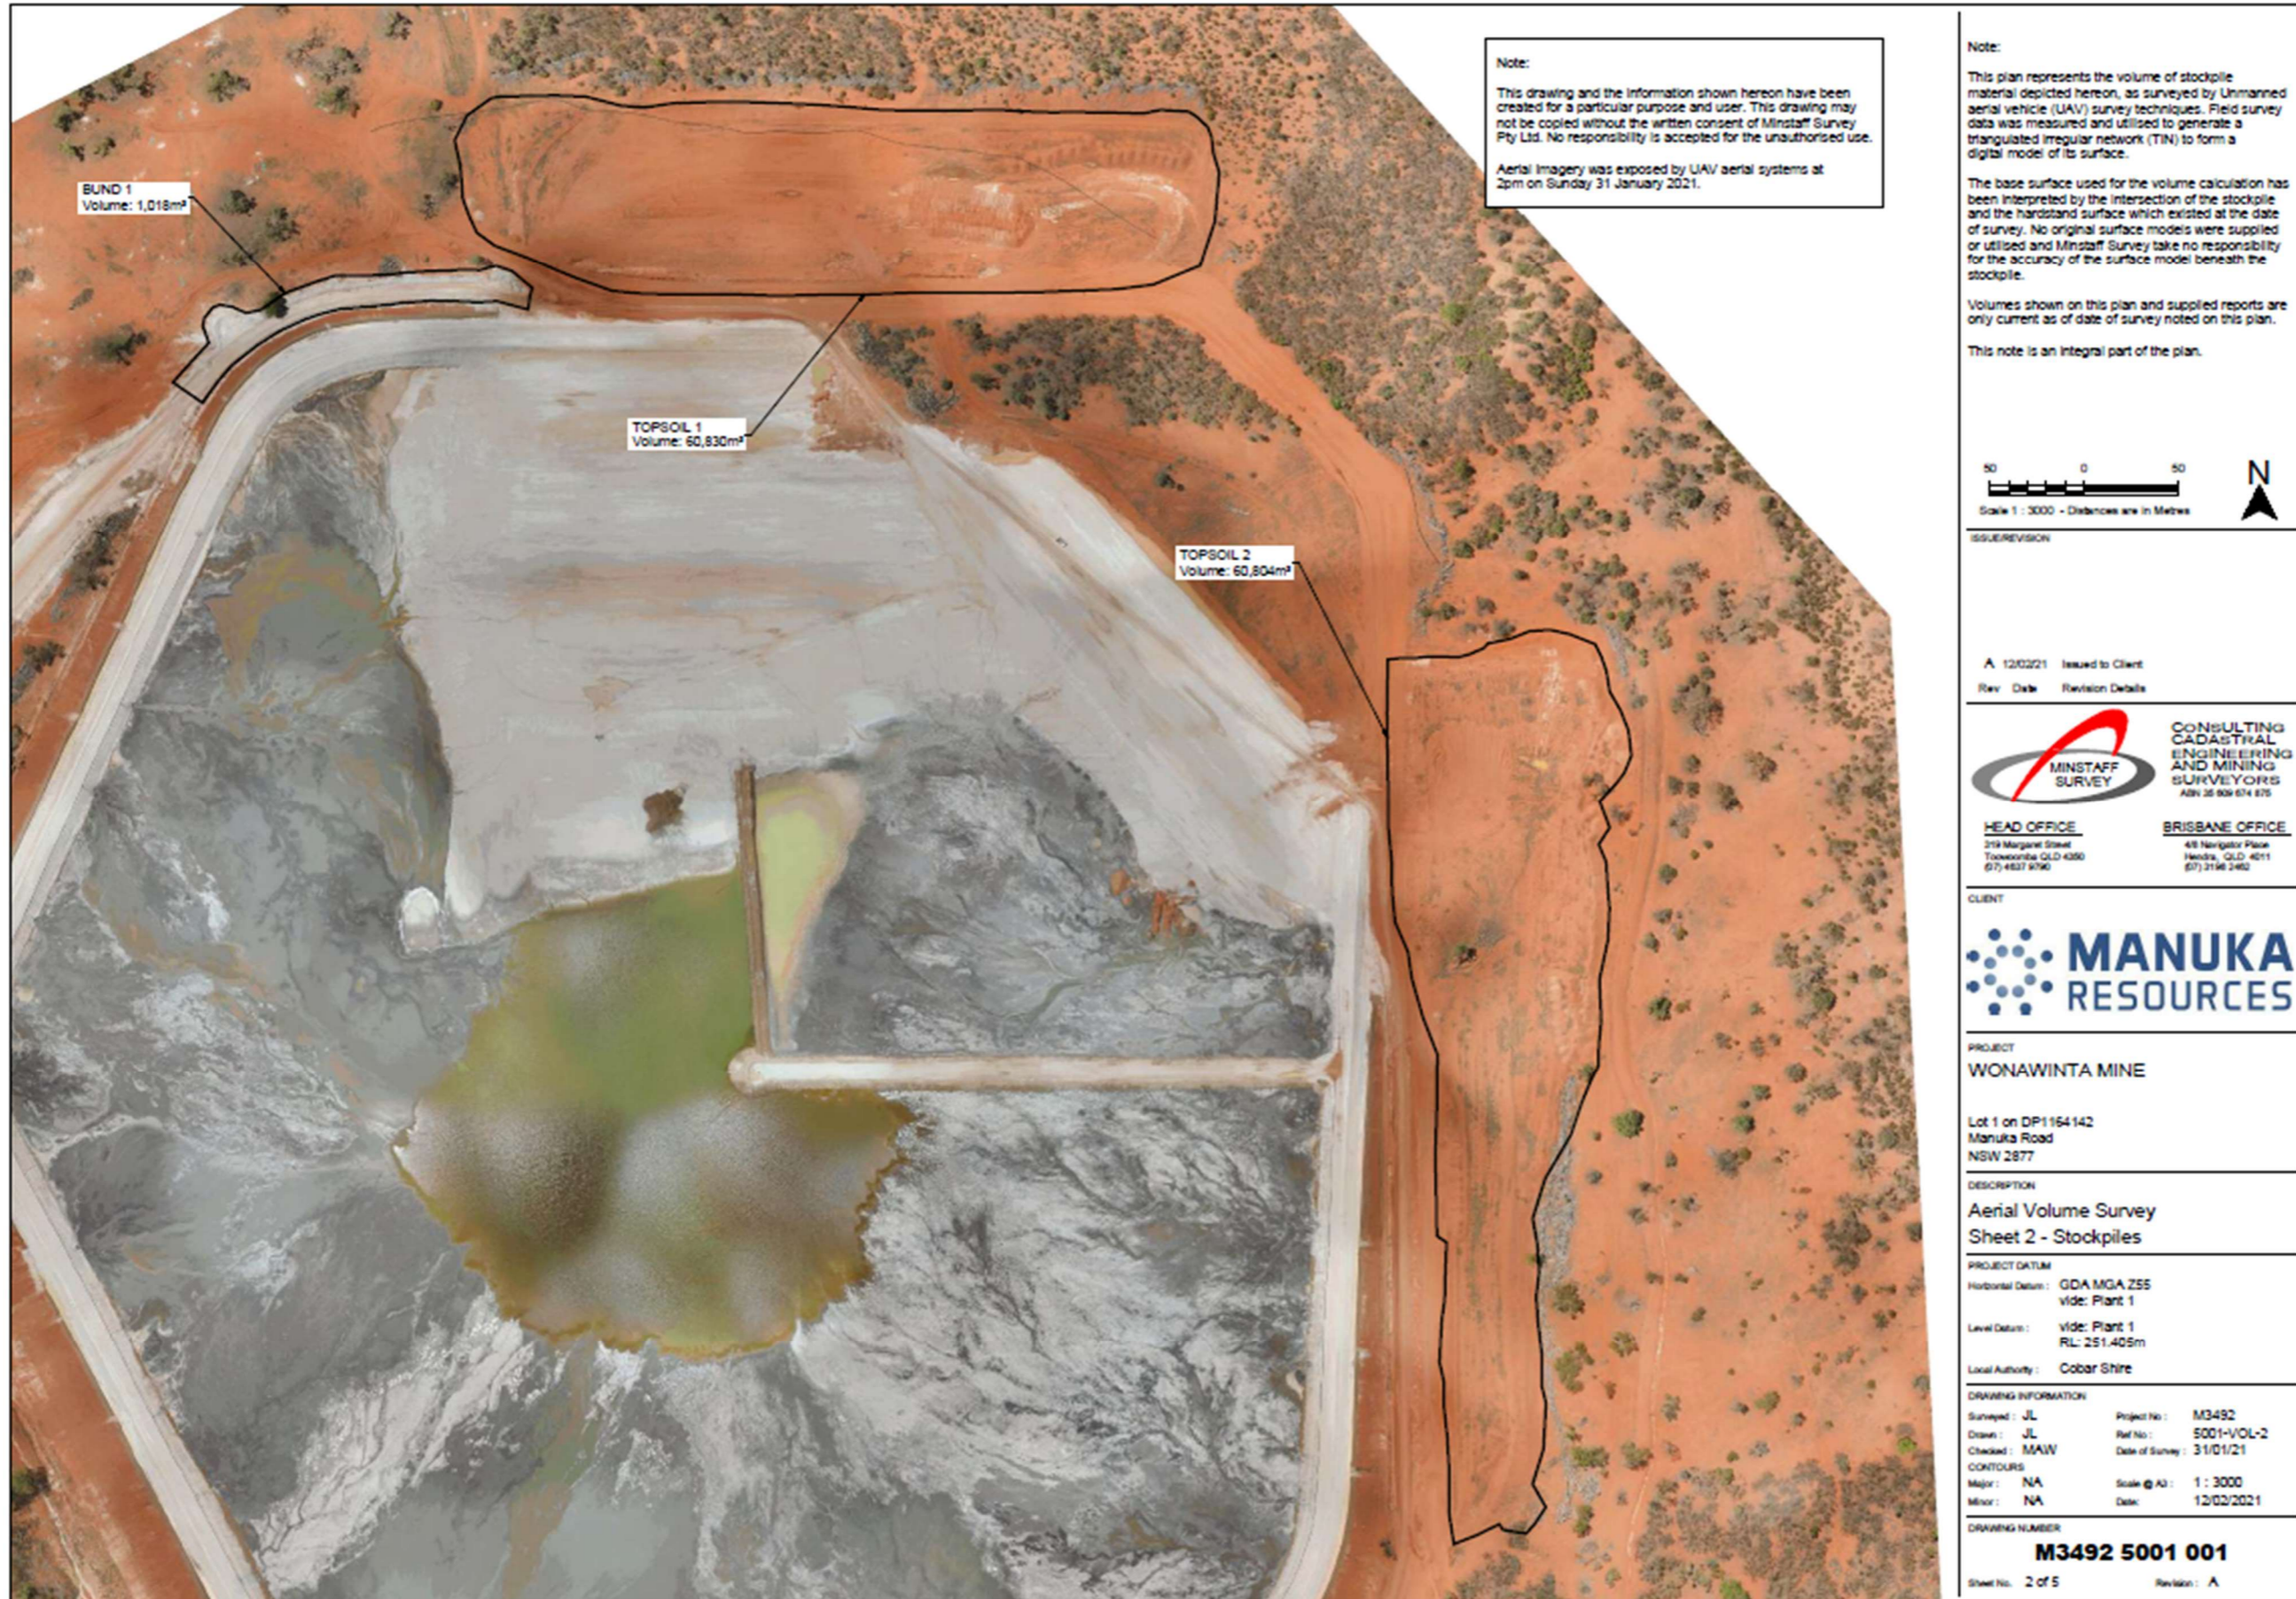
Note:
 This plan represents the volume of stockpile material depicted hereon, as surveyed by Unmanned aerial vehicle (UAV) survey techniques. Field survey data was measured and utilised to generate a triangulated irregular network (TIN) to form a digital model of its surface.
 The base surface used for the volume calculation has been interpreted by the intersection of the stockpile and the hardstand surface which existed at the date of survey. No original surface models were supplied or utilised and Minstaff Survey take no responsibility for the accuracy of the surface model beneath the stockpile.
 Volumes shown on this plan and supplied reports are only current as of date of survey noted on this plan.
 This note is an integral part of the plan.

Figure 16: February 2021 Stockpile Survey Update – Topsoil Stockpiles North and North-East of TSF
