**REHABILITATION
MANAGEMENT PLAN**

Manuka Mine

Project Director: Luke Bettridge
Project Manager: Nadia Aurisch
Report No. MRL-ENV-PLN-007
Date: December 2022

Wonawinta Mine: Material Characterisation Report

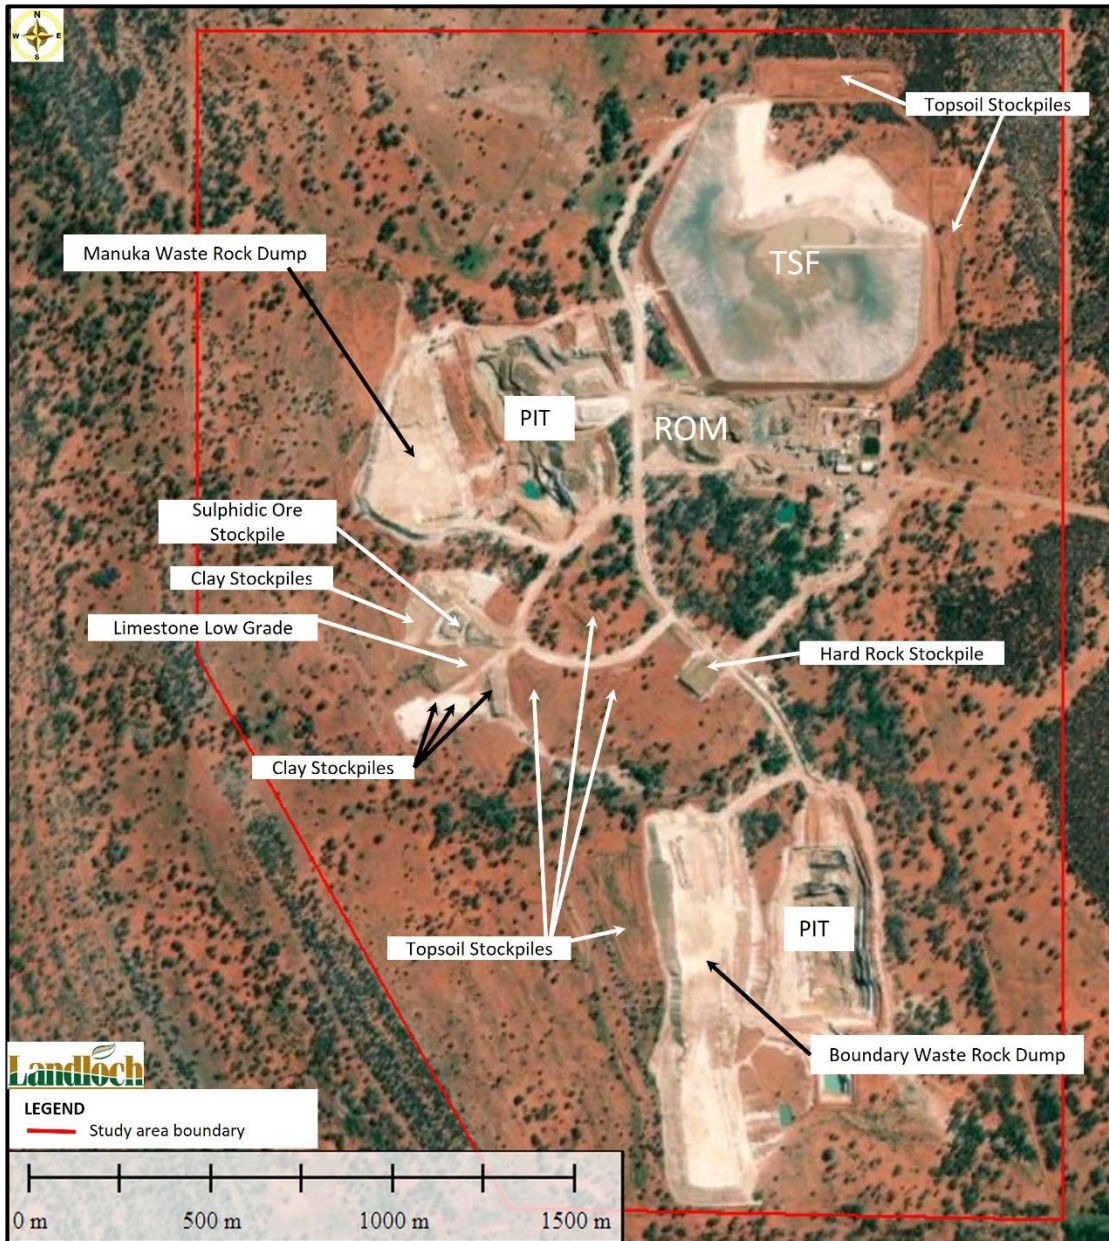
Figure 1: Aerial image of Wonawinta Mine, with locations of sampled stockpiles.

Manuka Resources engaged Landloch to undertake characterisation of rock, waste, substrate and soil materials at the Wonawinta Silver Mine (the Mine) (Figure 1). The characterisation aimed to assess the physical and chemical properties of the materials, and their suitability for supporting vegetation and post mining land uses. This report discusses the results of the sampling process, and provides recommendations for the amendment of various materials.

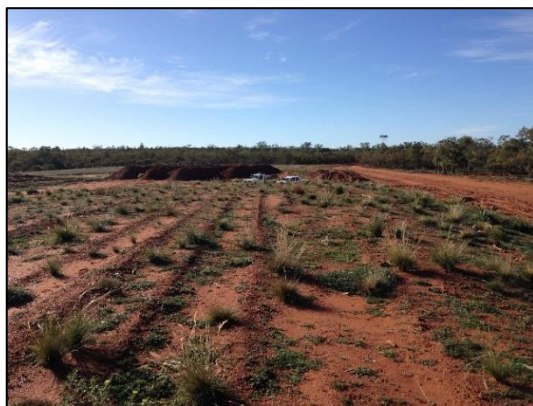
Photograph 1 Landscape of Topsoil Stockpile at Site TSP01.

The materials found in the Topsoil Stockpiles were mostly recovered surface soil (topsoil) materials. The stockpiles were generally similar in morphology. These materials were predominantly red to red-brown in colour. They were apedal, powdery, friable and loamy textured. The exception is a sample taken from TSP07 that was identified as a subsoil material, and was lower in organic carbon and higher in coarse fragments than the surface soil materials.

A representative photo of a Topsoil Stockpile is provided in Photograph 1, and a representative photo of topsoil materials is provided in Photograph 2.

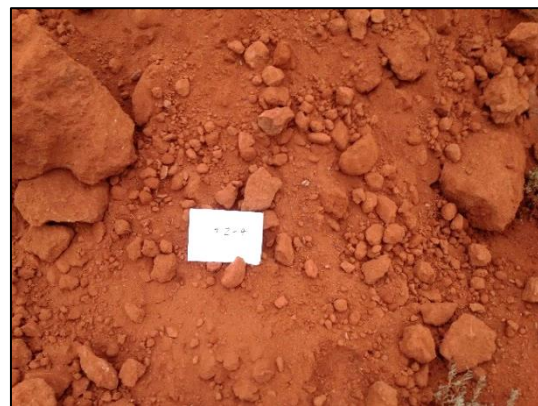
Photograph 2 Excavated material in Topsoil Stockpile at Site TSP02.

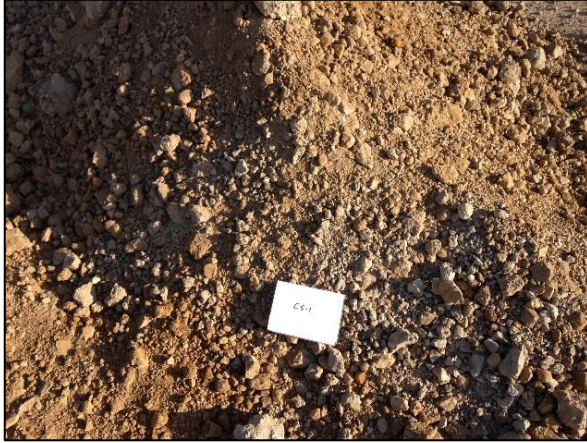
Photograph 3 Surface of Clay Stockpile at Site 5.

The materials found in the Clay Stockpiles were all substrate (non-pedogenic) materials. They were predominantly pale, dense, massive, firm to hard, clay loams and clays. Representative photos of Clay Stockpile materials are provided in Photograph 3 and Photograph 4.

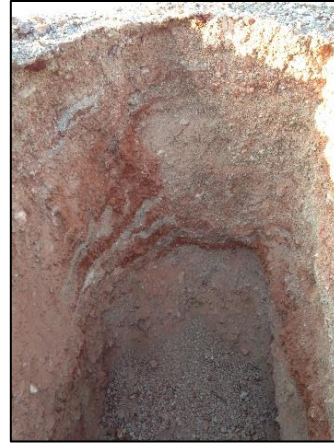
Photograph 4. Excavation in Clay Stockpile at Site CSP06.

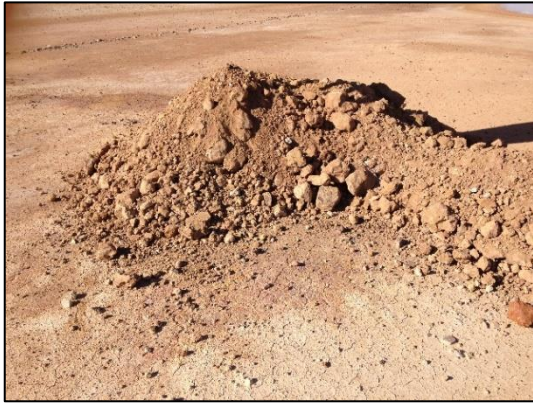
Photograph 5 Excavated material at the Boundary WRD.

Representative photos of WRD and Stockpile materials are provided in Photograph 5 to Photograph 8.

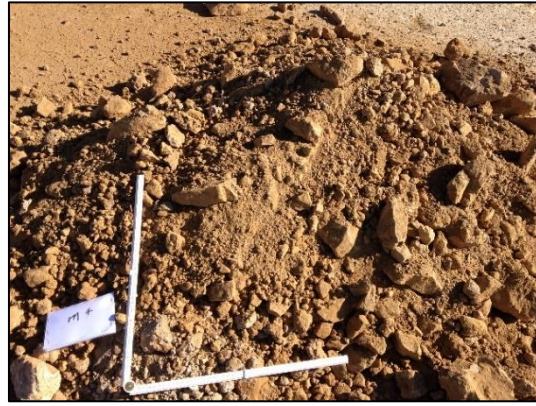
Photograph 6. Excavated material at the Boundary WRD Site M4.

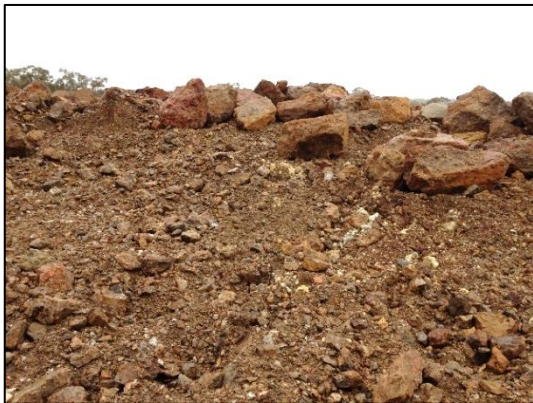
Photograph 7 Surface of Hard Rock Stockpile.

The Hard Rock Stockpile and Limestone Low Grade Stockpile were similar in appearance to each other. Both were dominated by hard rocky materials, with a soil-like component amongst the harder material.

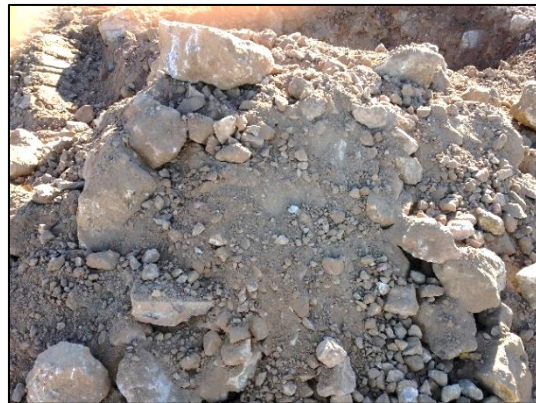
Photograph 8. Excavated material at the Limestone Low Grade Stockpile.

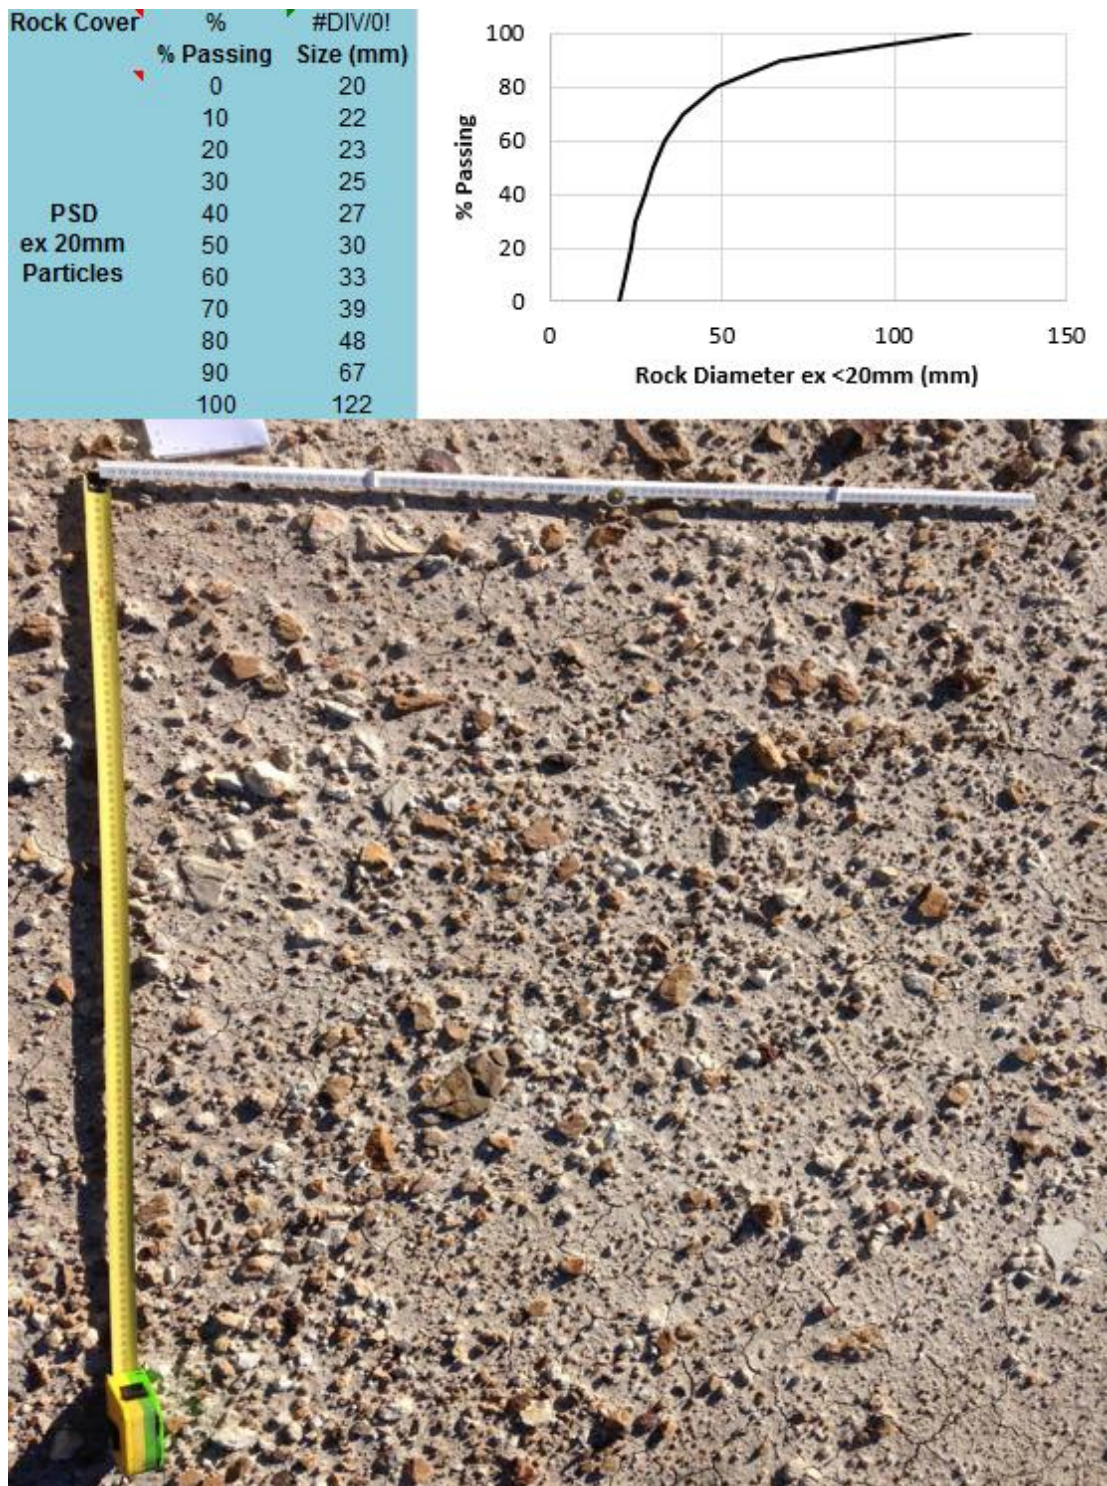
Figure D1: Undisturbed surface of the waste rock materials at the Boundary WRD -Site B-6.

Rock Cover	%	#DIV/0!
	% Passing	Size (mm)
	0	20
	10	22
	20	23
	30	25
PSD	40	28
ex 20mm	50	33
Particles	60	37
	70	48
	80	58
	90	83
	100	116

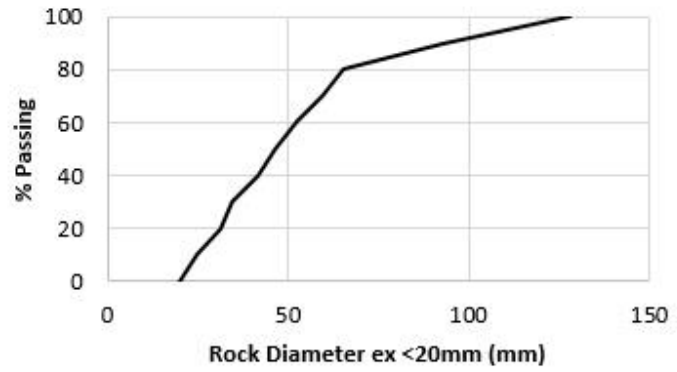
Figure D2: Undisturbed surface of the waste rock materials at the Manuku WRD -Site M-6.

Rock Cover	%	#DIV/0!
	% Passing	Size (mm)
	0	20
	10	25
	20	31
	30	35
PSD	40	42
ex 20mm	50	46
Particles	60	53
	70	59
	80	65
	90	93
	100	128

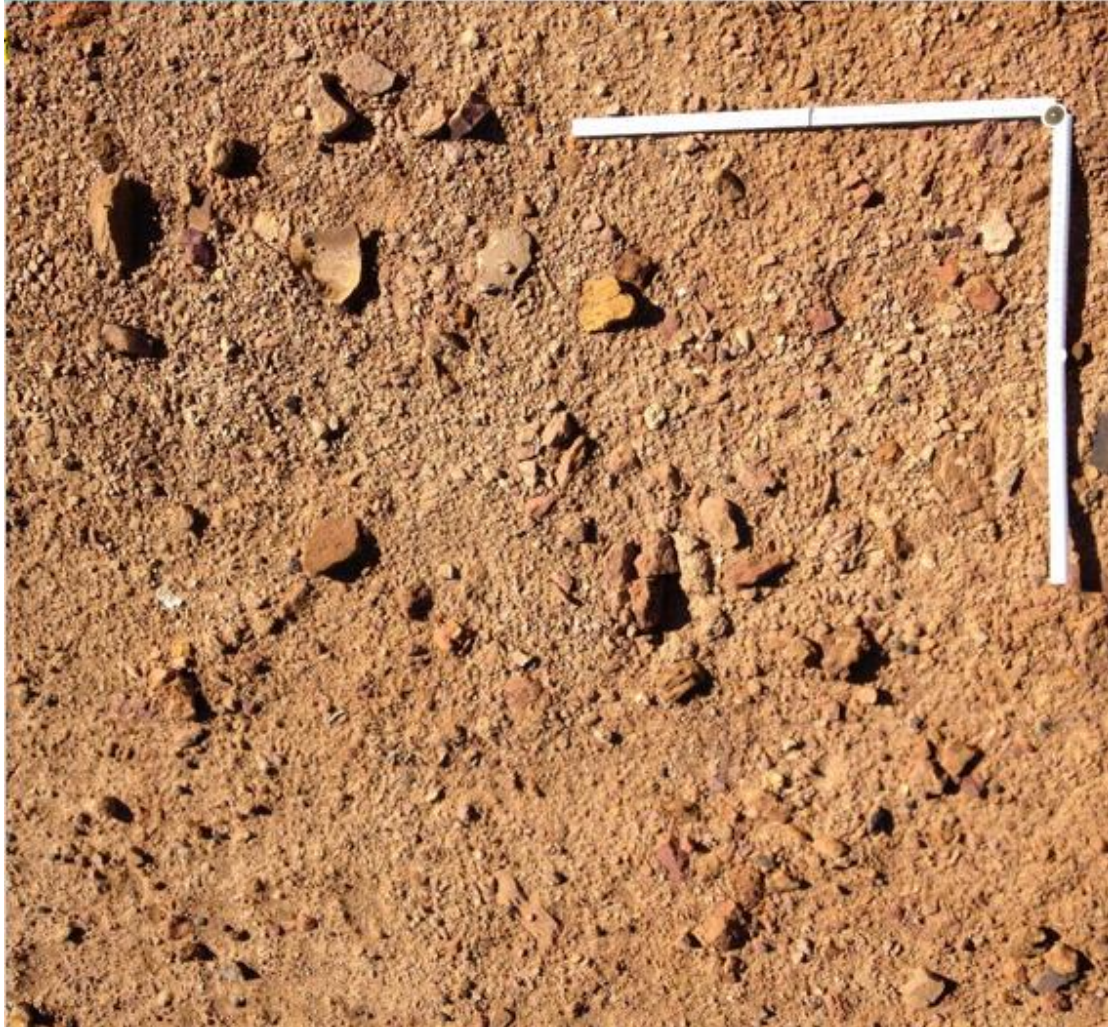
Figure D3: Undisturbed surface of the waste rock materials at the Manuku WRD -Site M-8.

Rock Cover	%	#DIV/0!
	% Passing	Size (mm)
	0	20
	10	26
	20	32
	30	39
PSD	40	47
ex 20mm	50	58
Particles	60	64
	70	80
	80	121
	90	205
	100	428

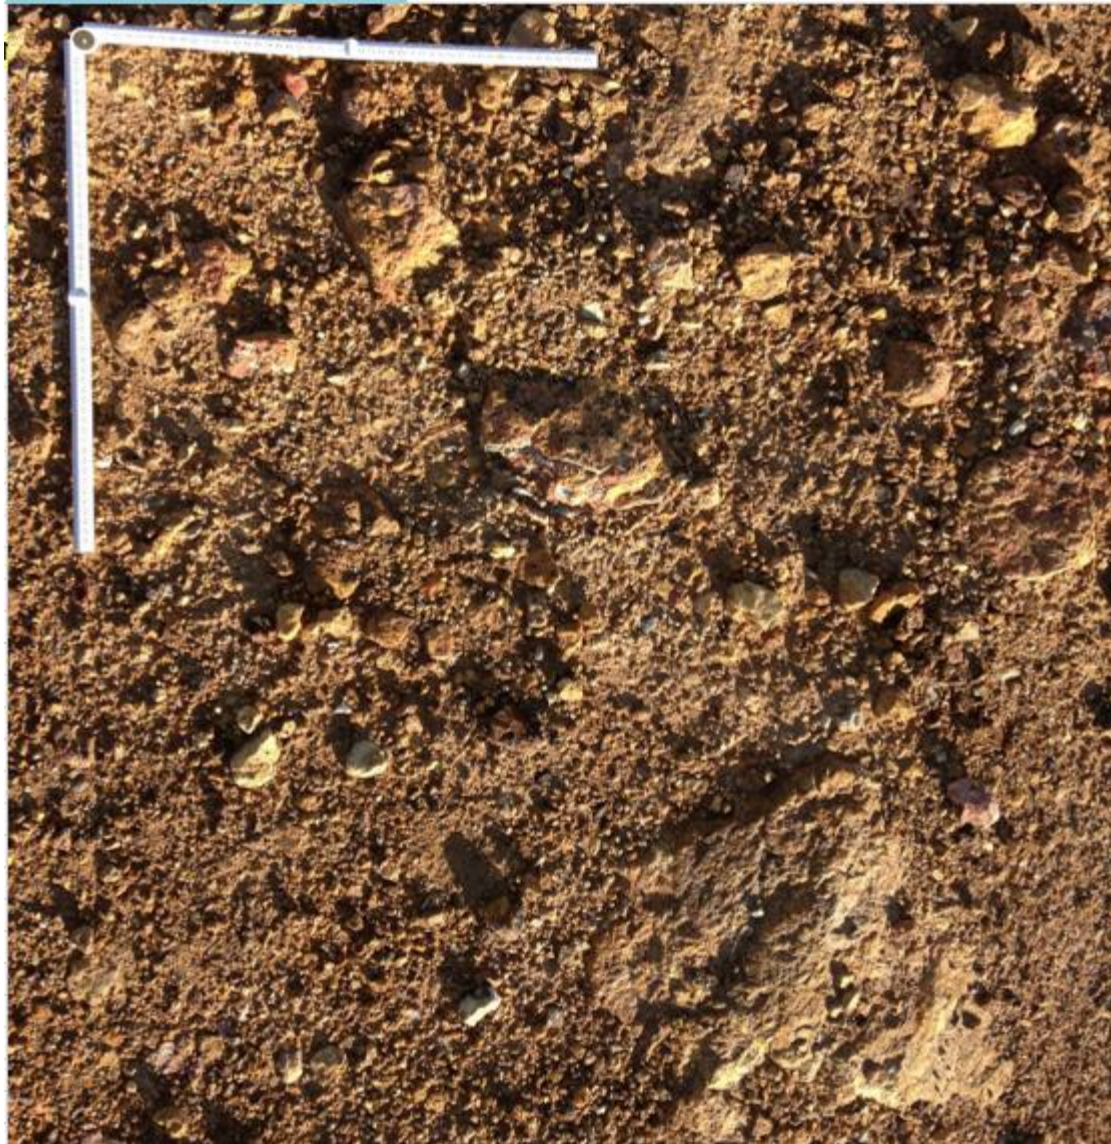
Figure D4: Undisturbed surface of the waste rock materials at the Limestone Stockpile - Site LL-1.

Rock Cover	%	#DIV/0!
	% Passing	Size (mm)
	0	20
	10	26
	20	34
	30	40
PSD	40	48
ex 20mm	50	56
Particles	60	68
	70	86
	80	115
	90	143
	100	221

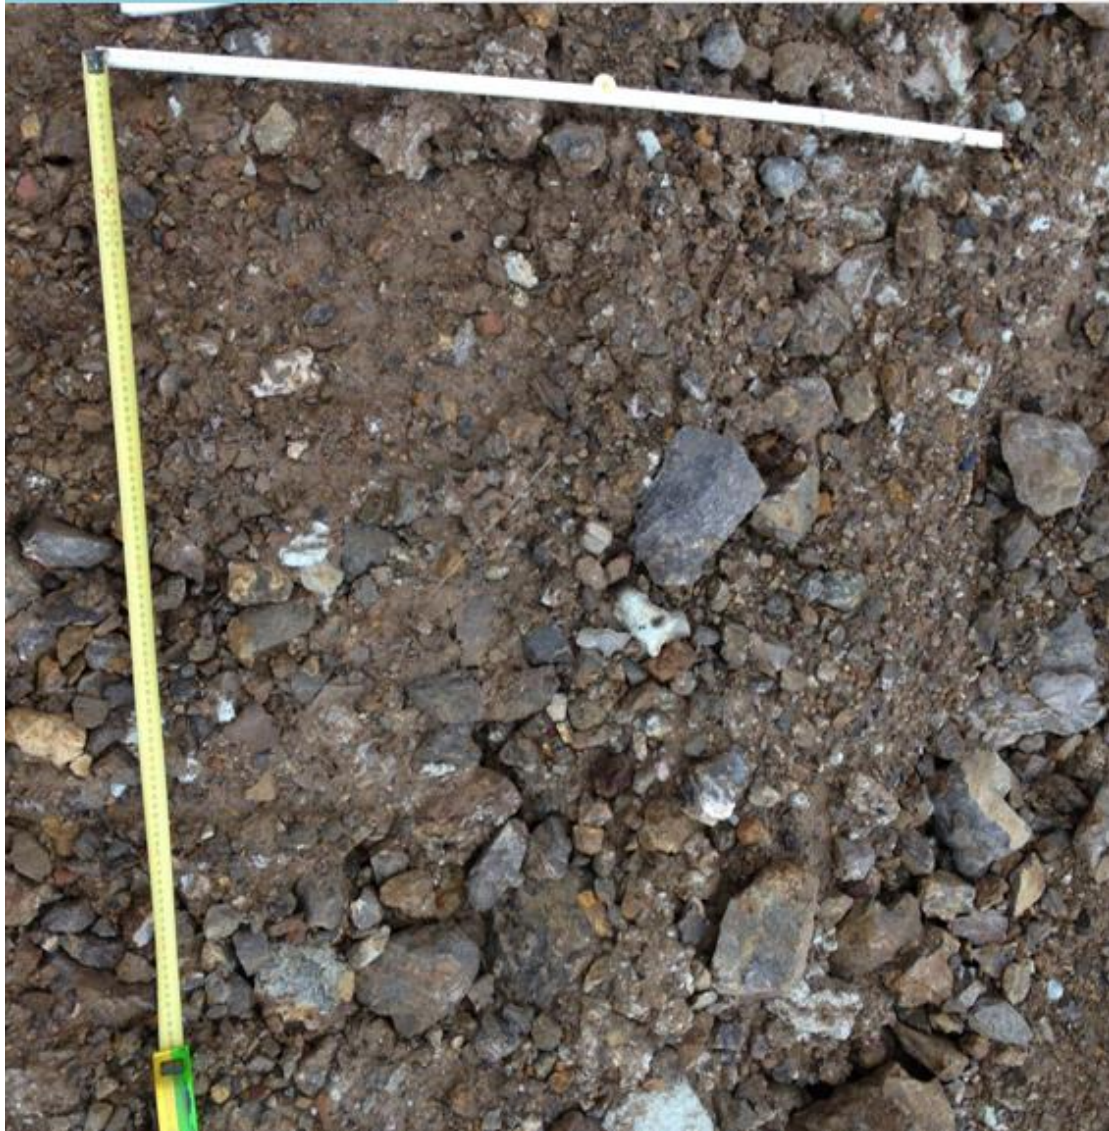
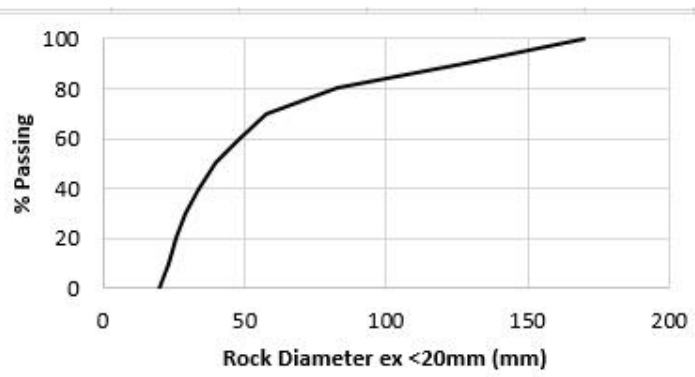
Figure D5: Undisturbed surface of the waste rock materials at the Hard Rock Stockpile - Site HR-2.

Rock Cover	%	#DIV/0!
	% Passing	Size (mm)
	0	20
	10	23
	20	26
	30	29
PSD	40	34
ex 20mm	50	39
Particles	60	48
	70	57
	80	83
	90	128
	100	170

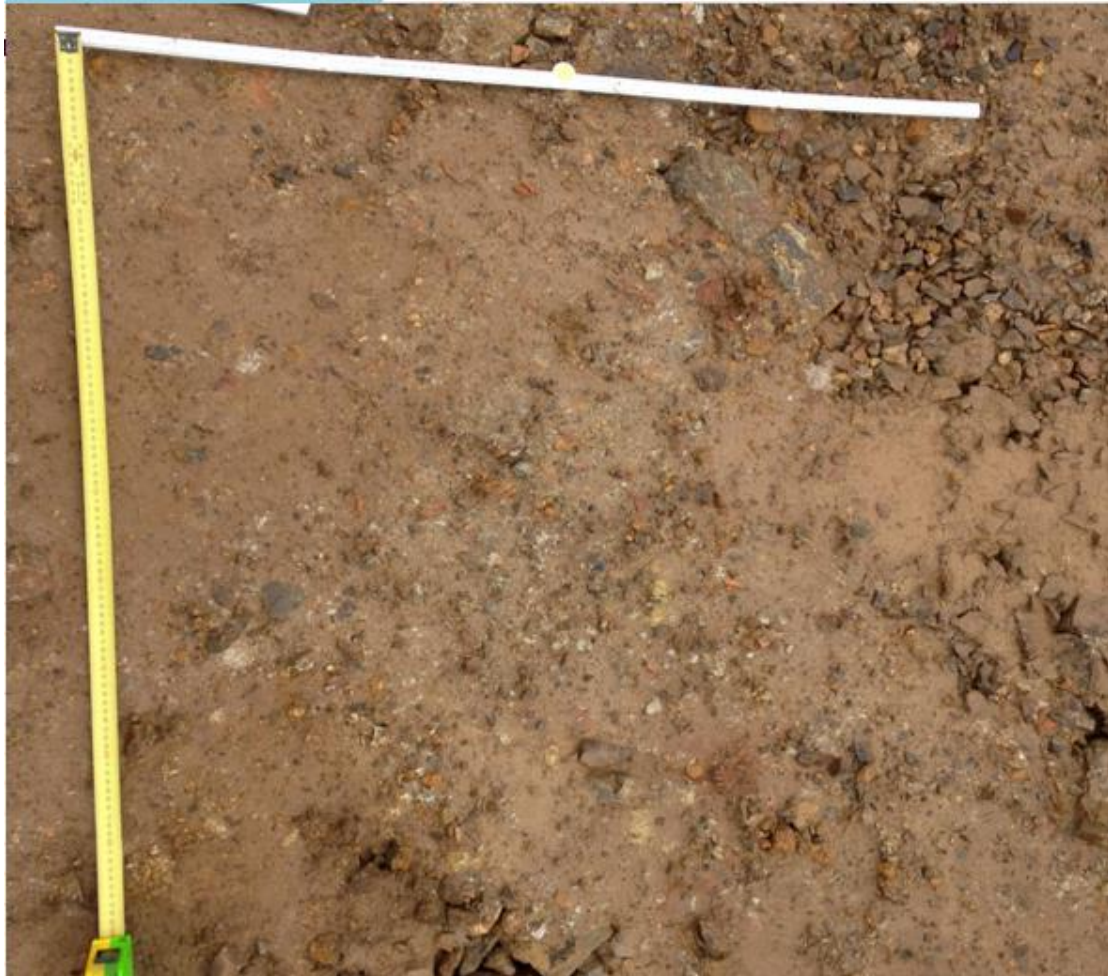
Figure D6: Undisturbed surface of the waste rock materials at the Hard Rock Stockpile - Site HR-3.

Rock Cover	%	#DIV/0!
PSD ex 20mm Particles	% Passing	Size (mm)
	0	20
	10	25
	20	31
	30	36
	40	44
	50	49
	60	59
	70	72
	80	85
	90	102
	100	159

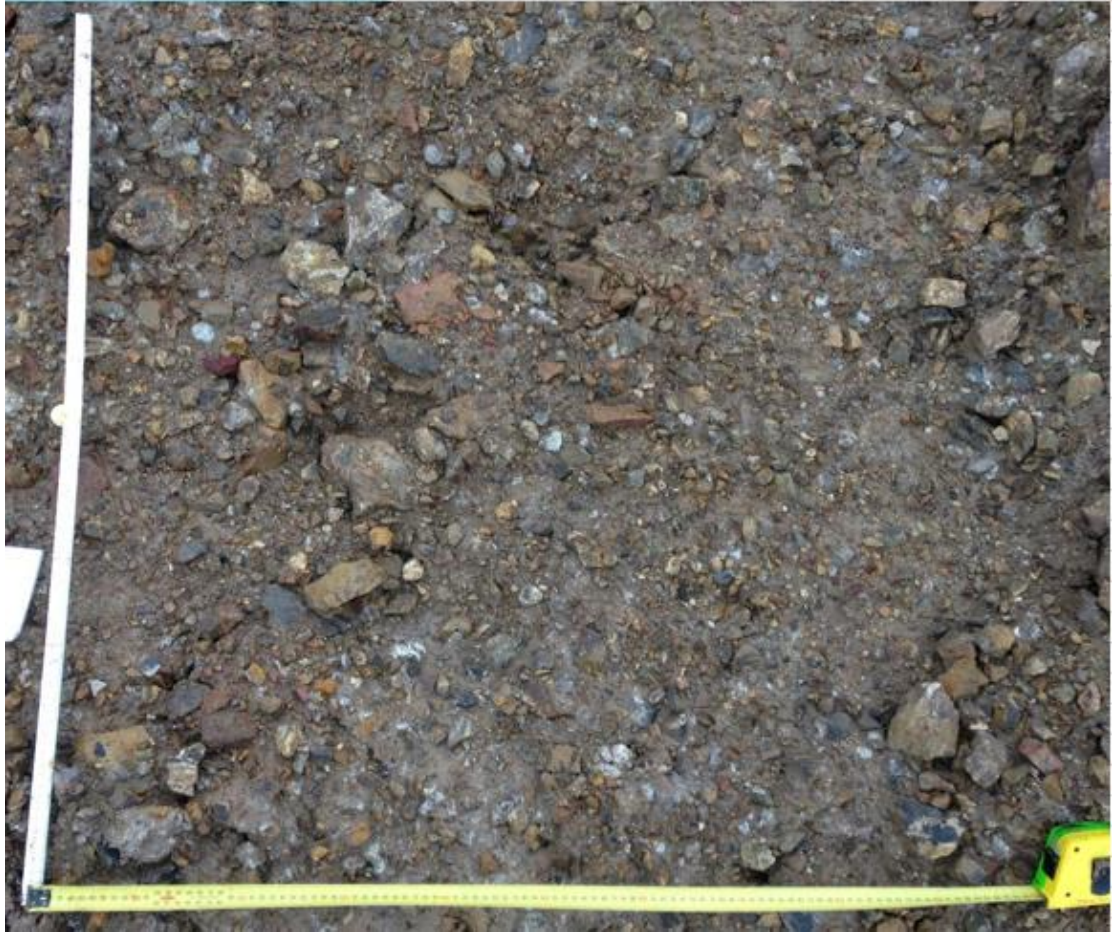
Figure D7: Undisturbed surface of the waste rock materials at the Hard Rock Stockpile - Site -6.
