REHABILITATION REPORT

19 January 2019 to 18 January 2020

Wonawinta Silver Project

Manuka Silver Mine

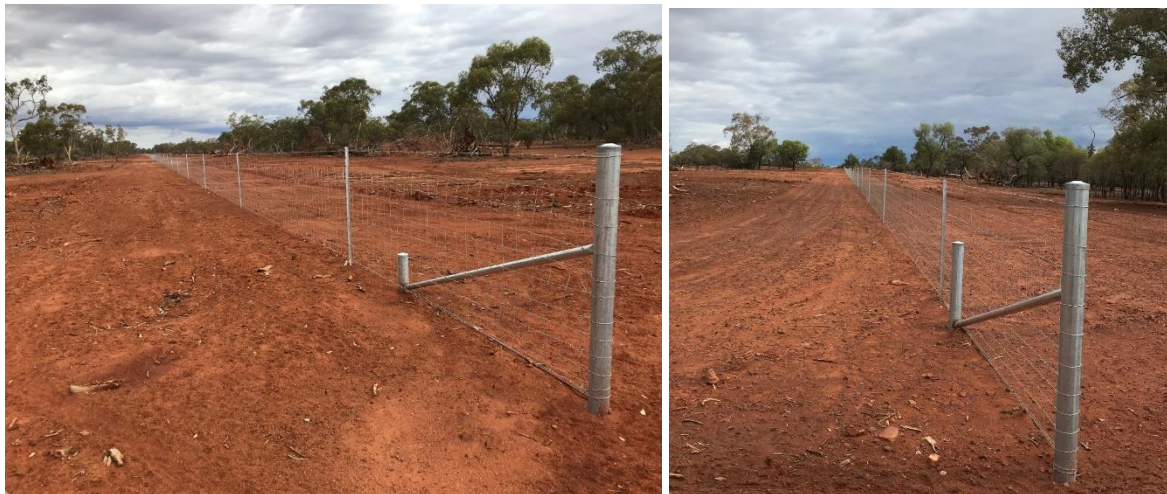
Figure 7d Biodiversity offset boundaries

During the period August 2019 to January 2020 new fencing was erected on Manuka mining lease to repair/replace exiting fencing which was in poor condition and allowing animals to stray onto the ML boundary. Areas which were repaired are shown in **Figures 7a - d** below. This area comprises the road between the camp and the plant and the eastern and western boundaries of the biodiversity offset area to the NE of the pastoral lease.

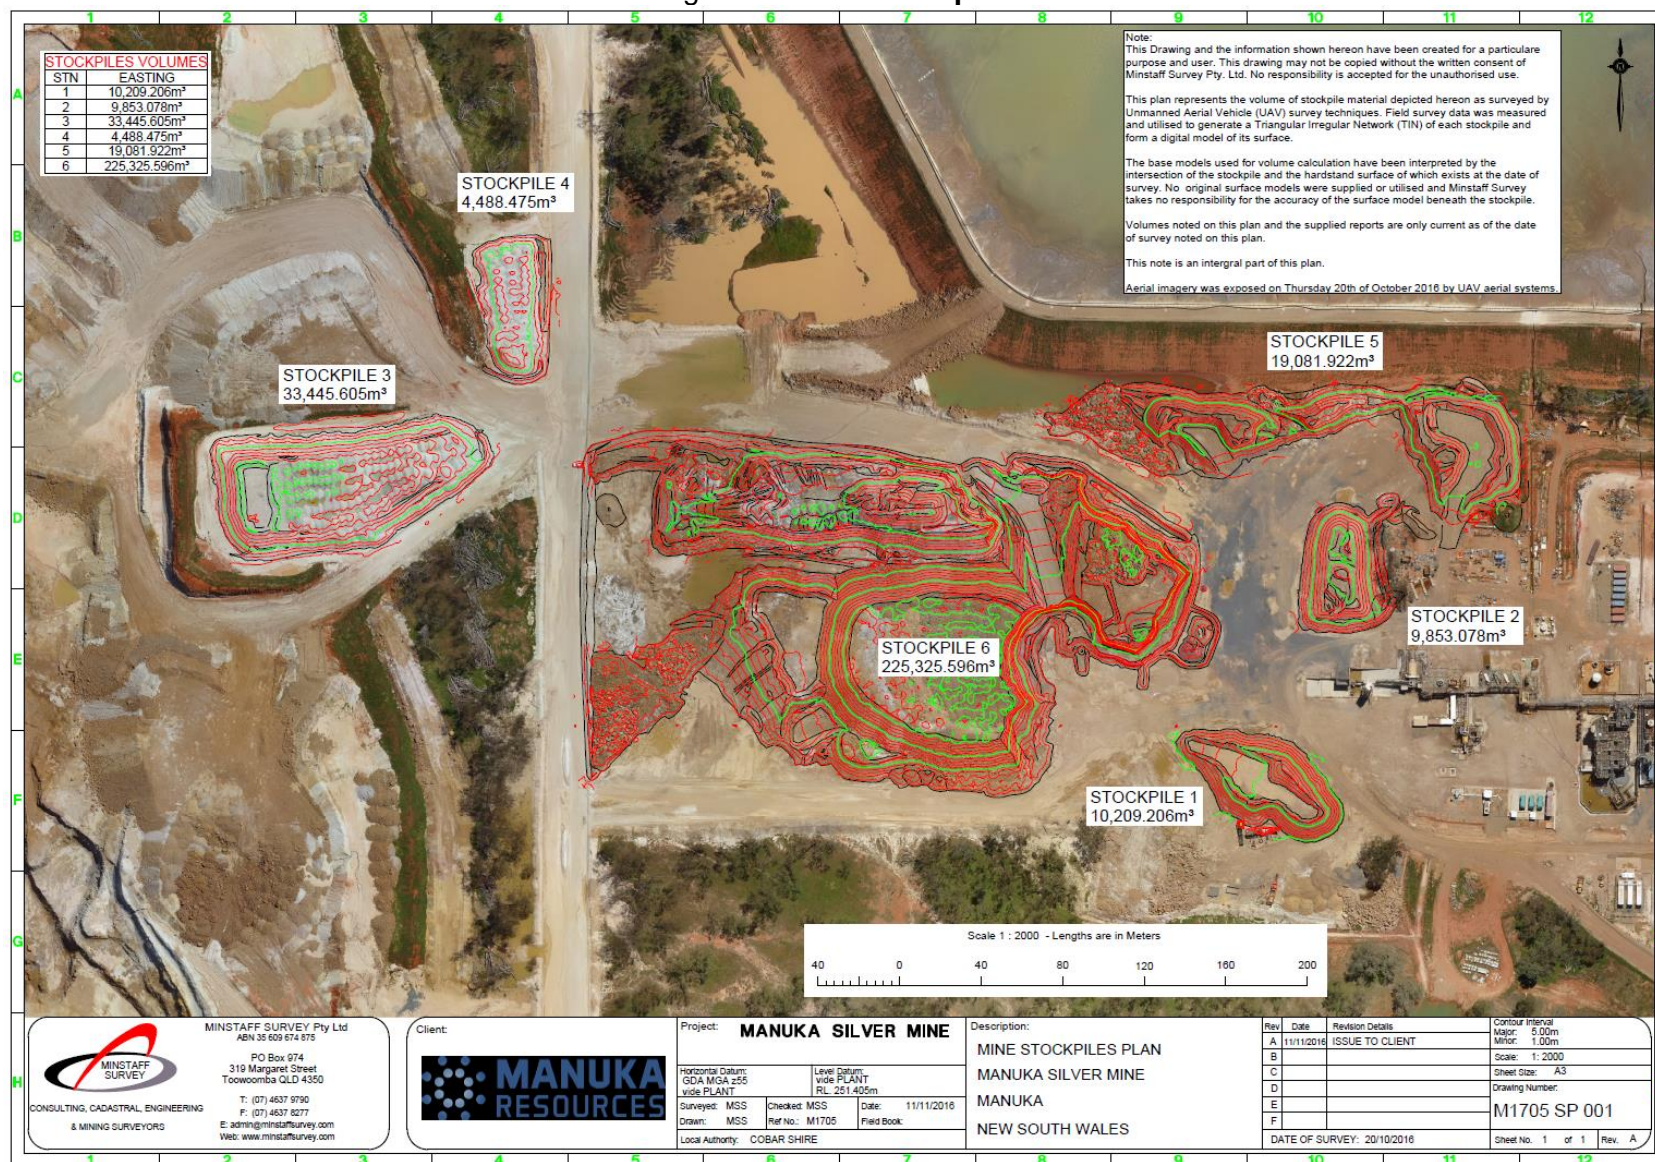
Figure 10. **Minor improvement Works in Progress for 2020 reporting period**

Some minor works have already commenced in the first part of 2020 (outside of this reporting period), and progress on these is shown in **figure 10** below.
