MANUKA RESOURCES

DAM SAFETY EMERGENCY PLAN

Doc Code	Title	Version	Effective Date	Review Date	Page
MRL-ENV-PLN-001	Dam Safety Emergency Plan	1.0			4 of 23

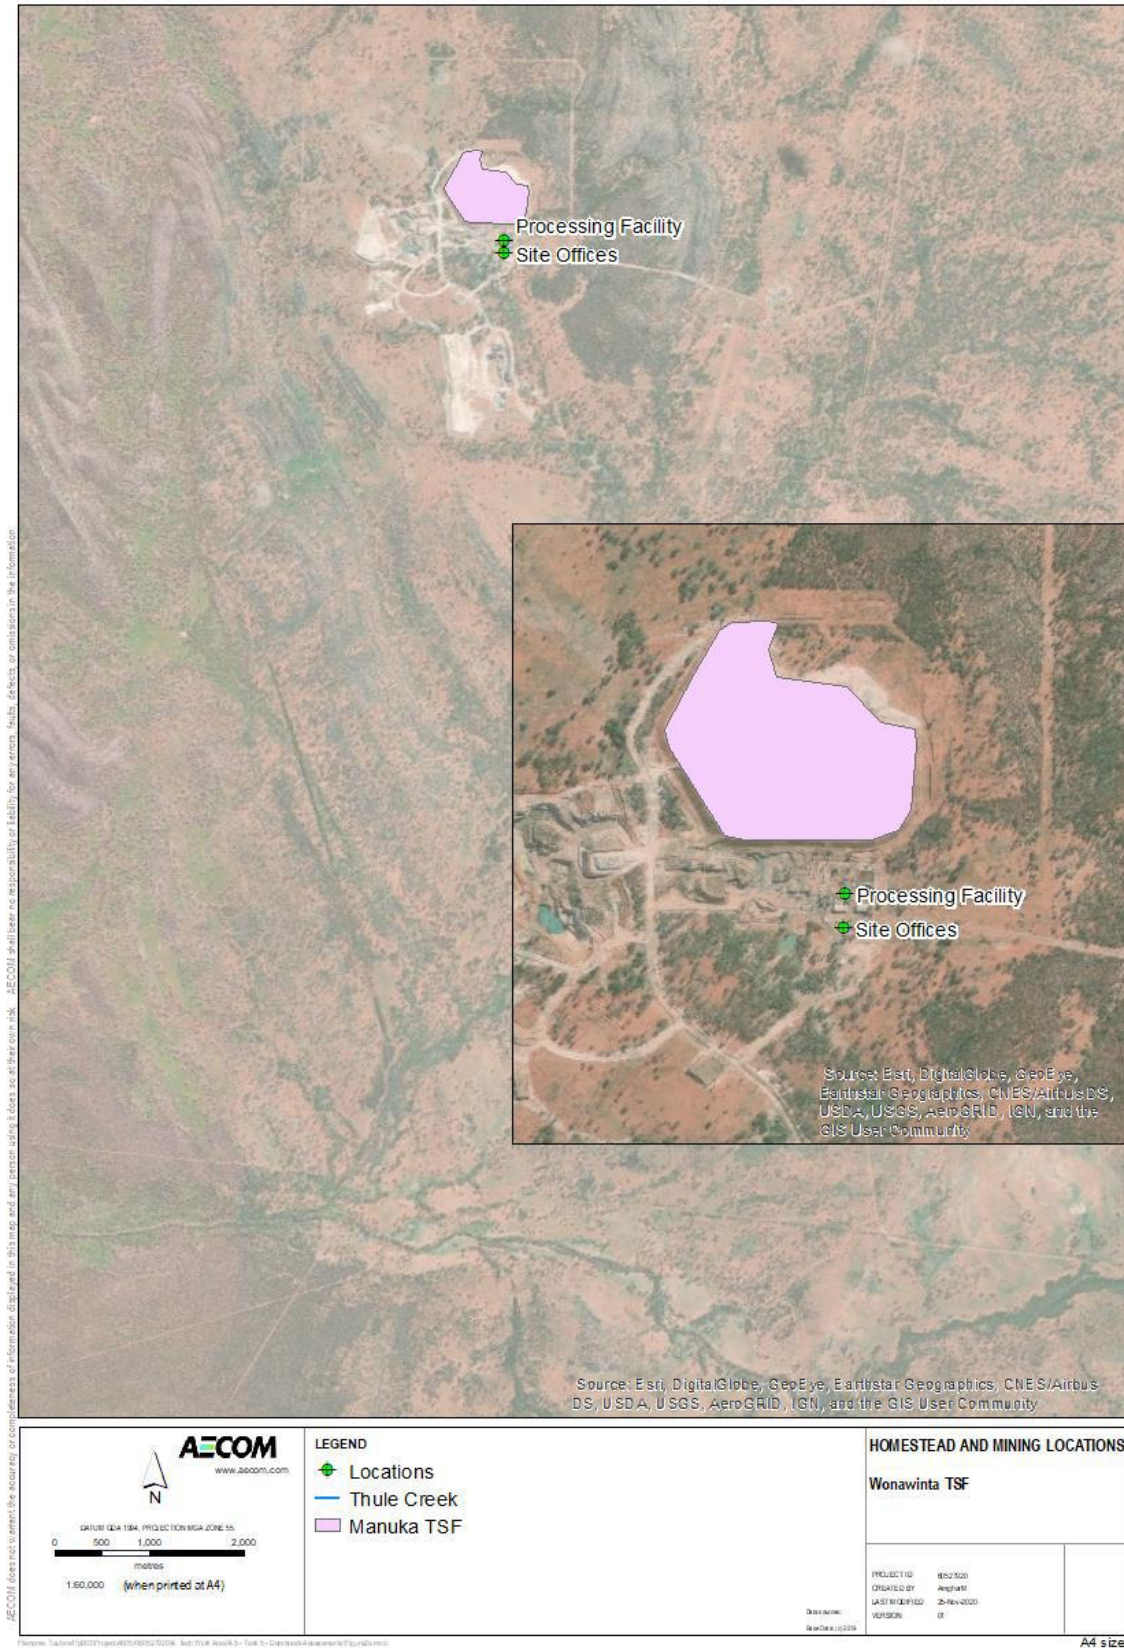
Figure 1 - Site Layout and Location

Figure 1 shows the location of the TSF in relation to the mining operations and Thule Creek. It is expected that the TSF will be a regulated dam which has been constructed accordingly and operated in accordance with the Environmental Authority (EA) conditions. General TSF information is provided in Table 2.

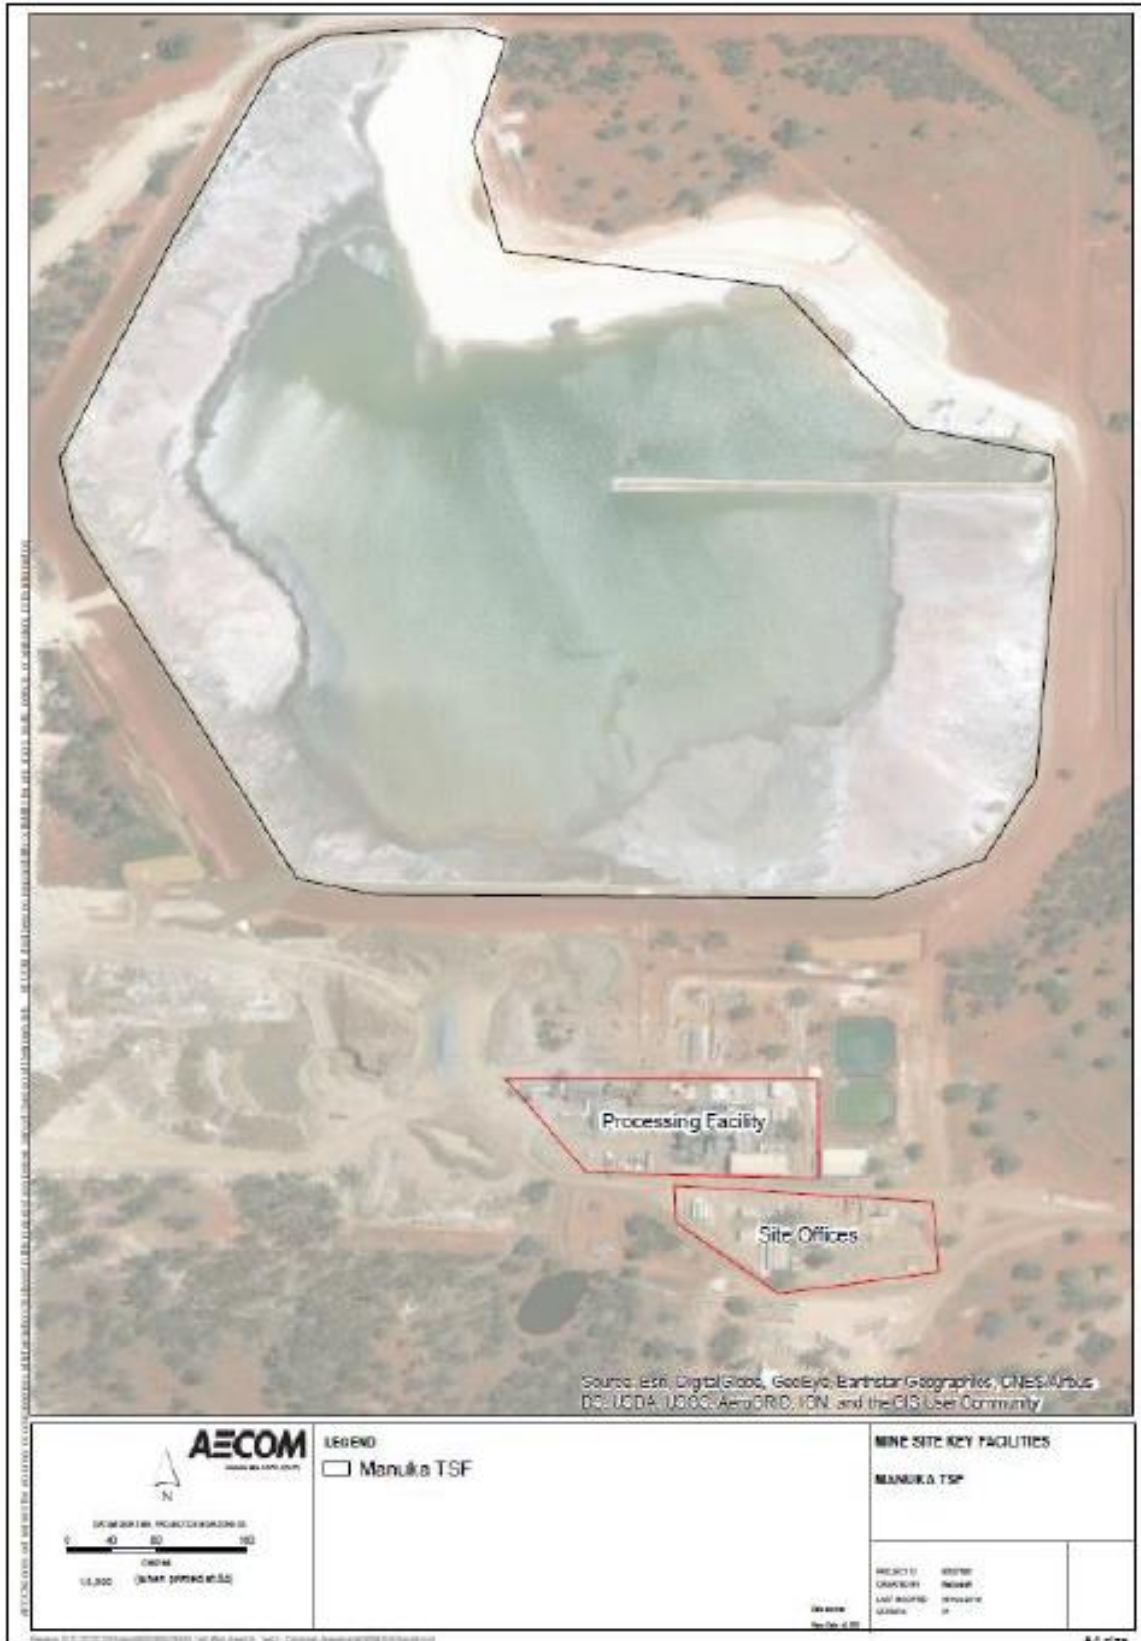
Figure 3 – Key Site Facilities Downstream of Manuka TSF

A few dwellings have been identified within a 15 km radius of the TSF. However, as the TSF contents is a mud/water mixture, the propagation is fairly limited and thus will not affect these downstream dwellings. However, some impacts to downstream infrastructure (Site office and Process Facility) could occur and are considered as part of this assessment. The locations identified as part of this assessment are shown in Figure 3, with the processing facility and site offices assessed as the at risk locations as part of this study.

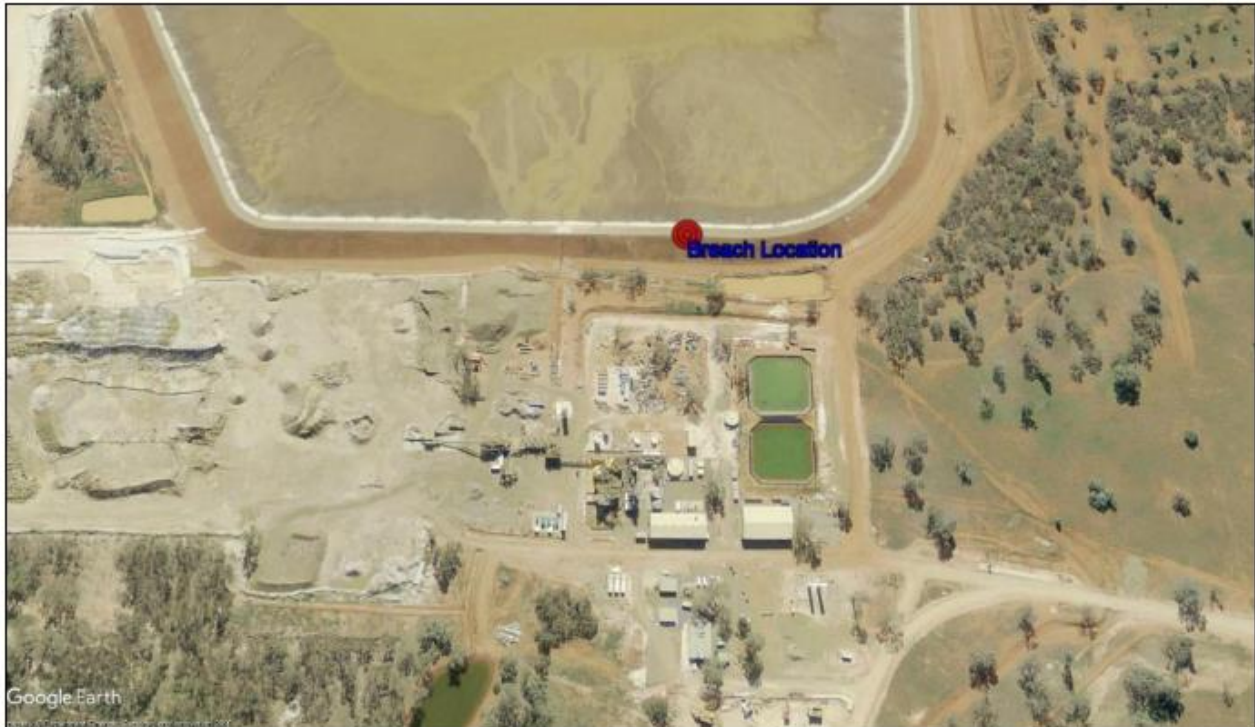
Figure 4 – Considered Breach Location

For the Manuka TSF Dam Break assessment, the breach location was considered along the TSF embankment, located south of the embankment. The selected breach location (A) is shown in Figure 4.

The breach location is the location or section of embankment where the failure is most likely to originate from. When undertaking the dam break assessment, the breach location chosen has a direct influence on the potential estimated impact. The following items were considered when selecting appropriate breach locations for the Manuka TSF:
